ABSOLUTE SOLUTIONS INC.

UNIVERSAL ACCESS FUND RTP SITE VALIDATION & ACCEPTANCE REPORT

8 February 2021

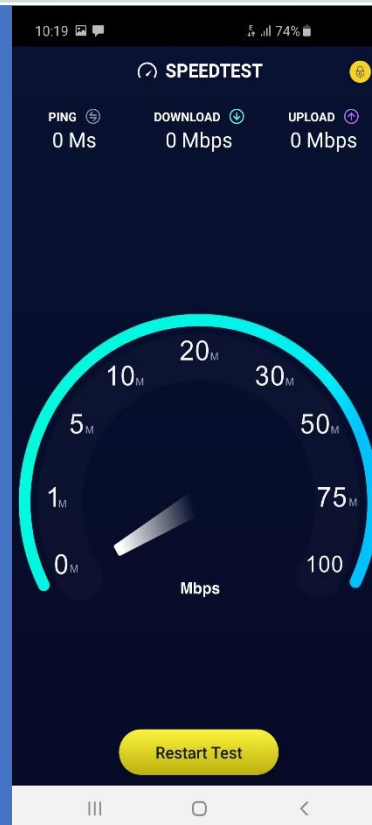
SPEED TEST RESULT

Ping: 0 ms
DL: 0 Mbps
UL: 0 Mbps

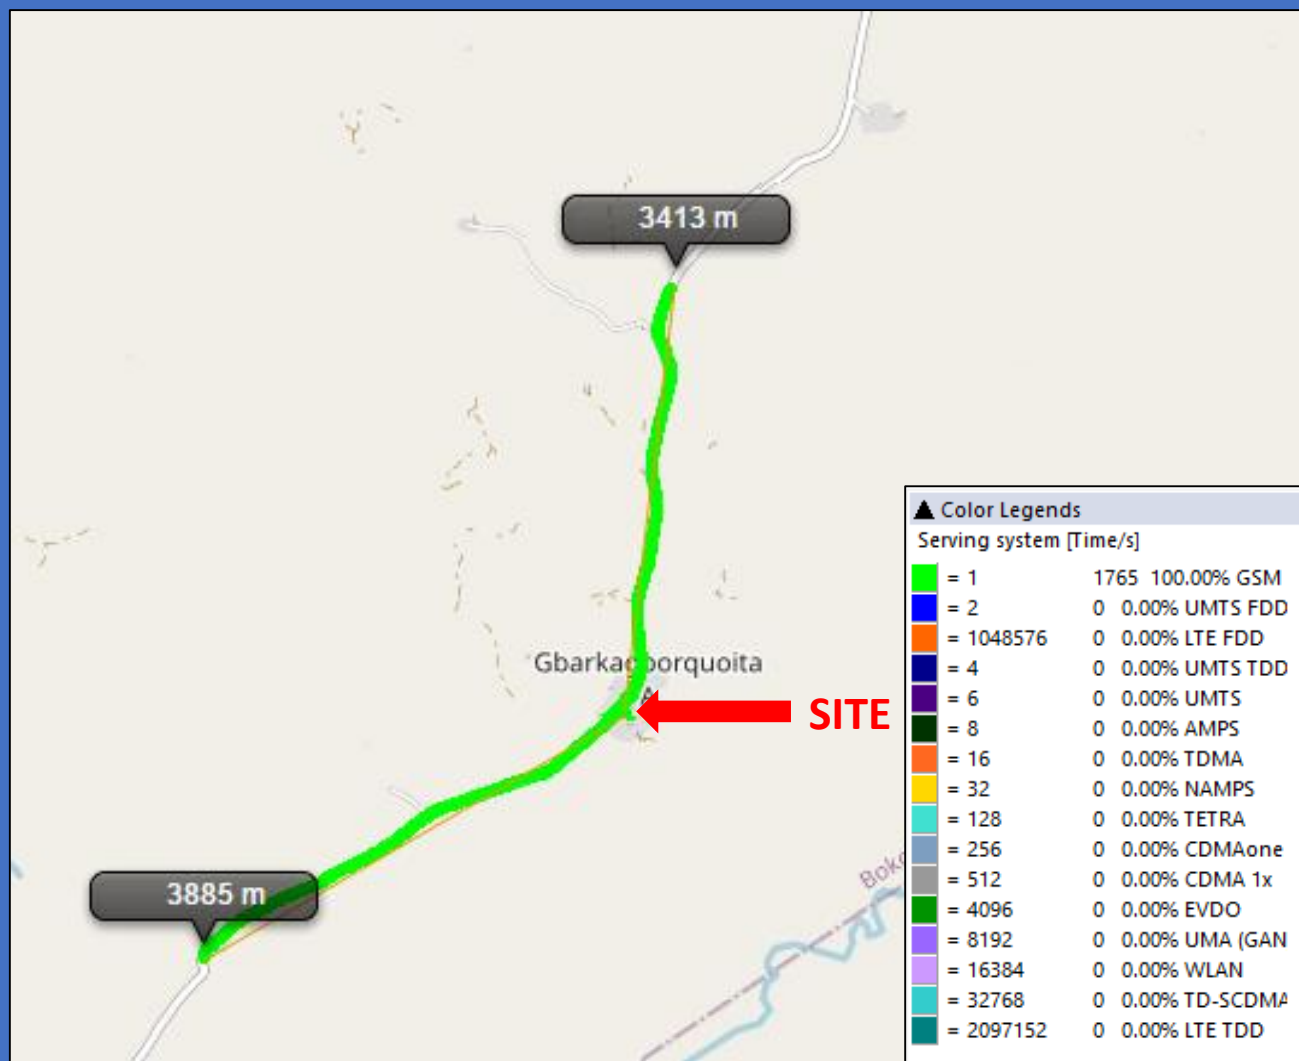
The site coverage radius is about 3.9 km with 100% in 2G network

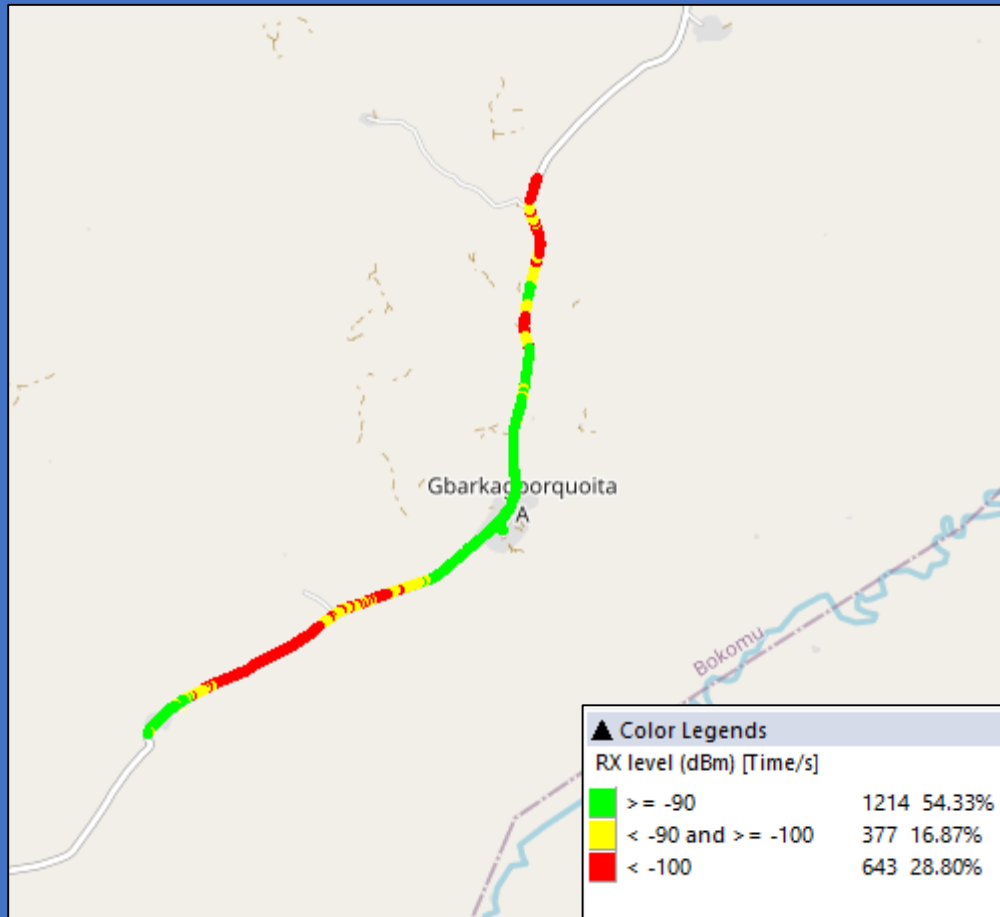
GSM coverage of the site is normal.

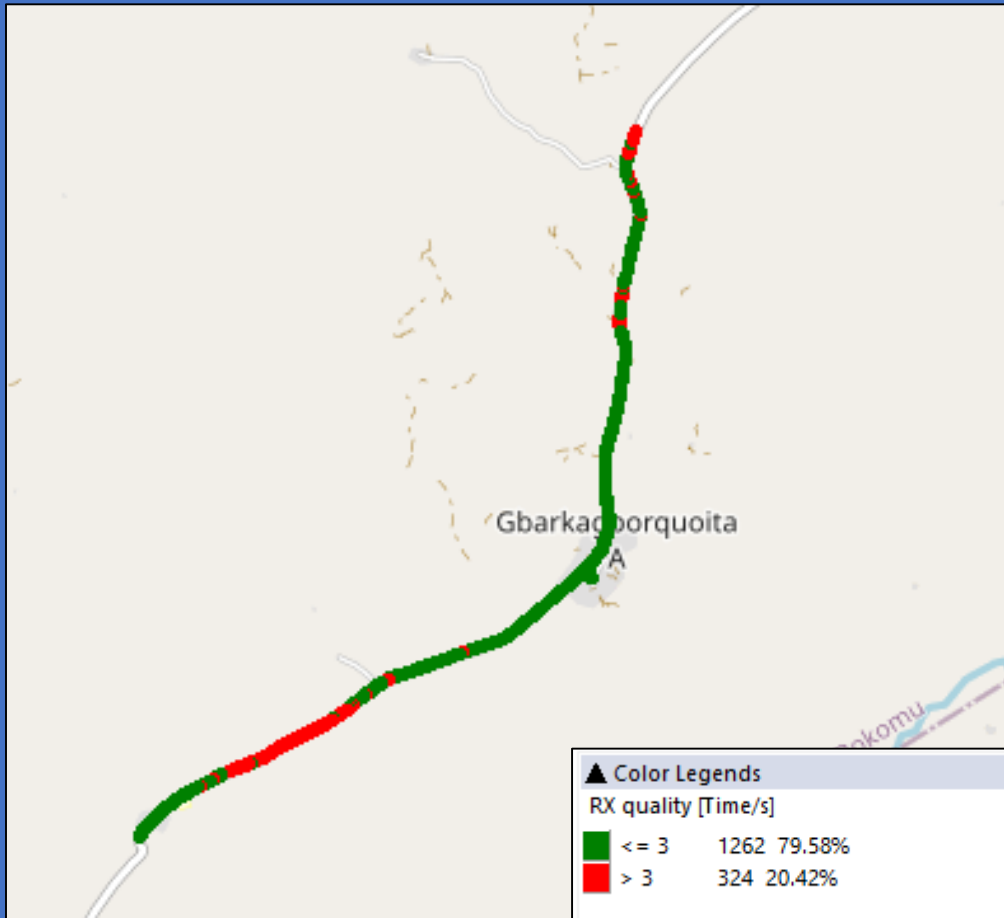
The site signal quality is normal.

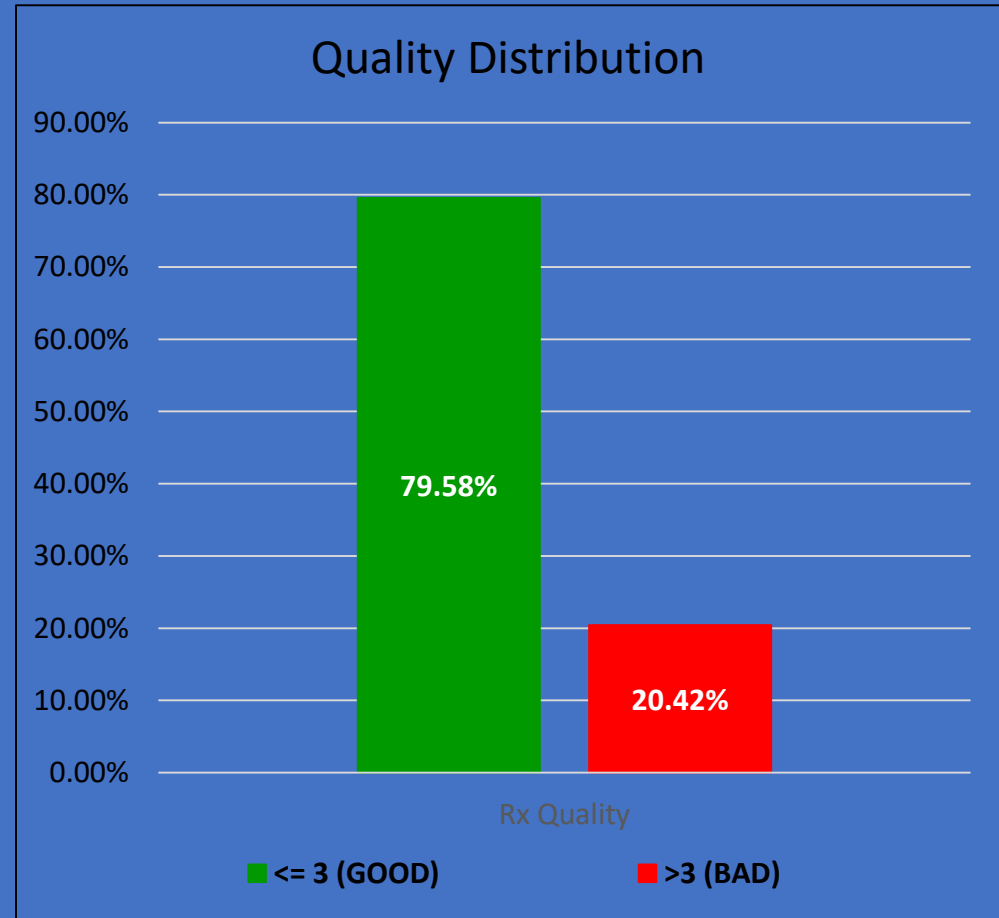
Signal Quality distribution. Bad quality originates from degradation in coverage.

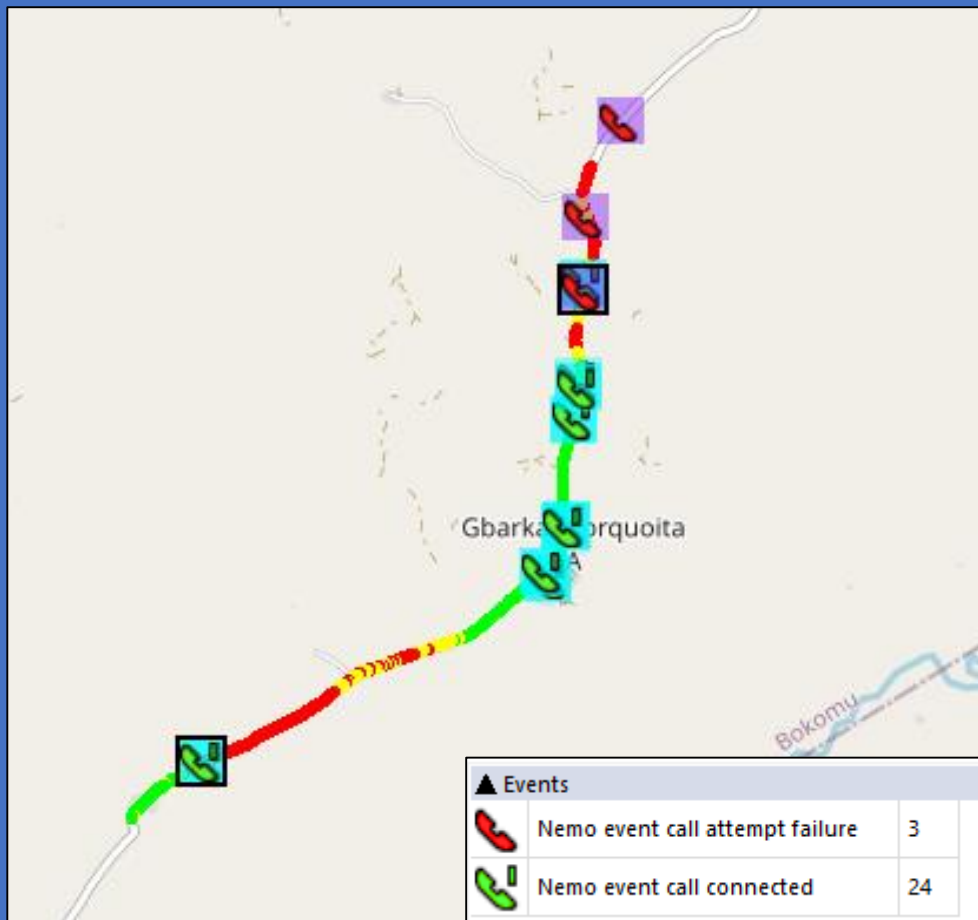
3 Call Setup failures; caused by weak signal level.

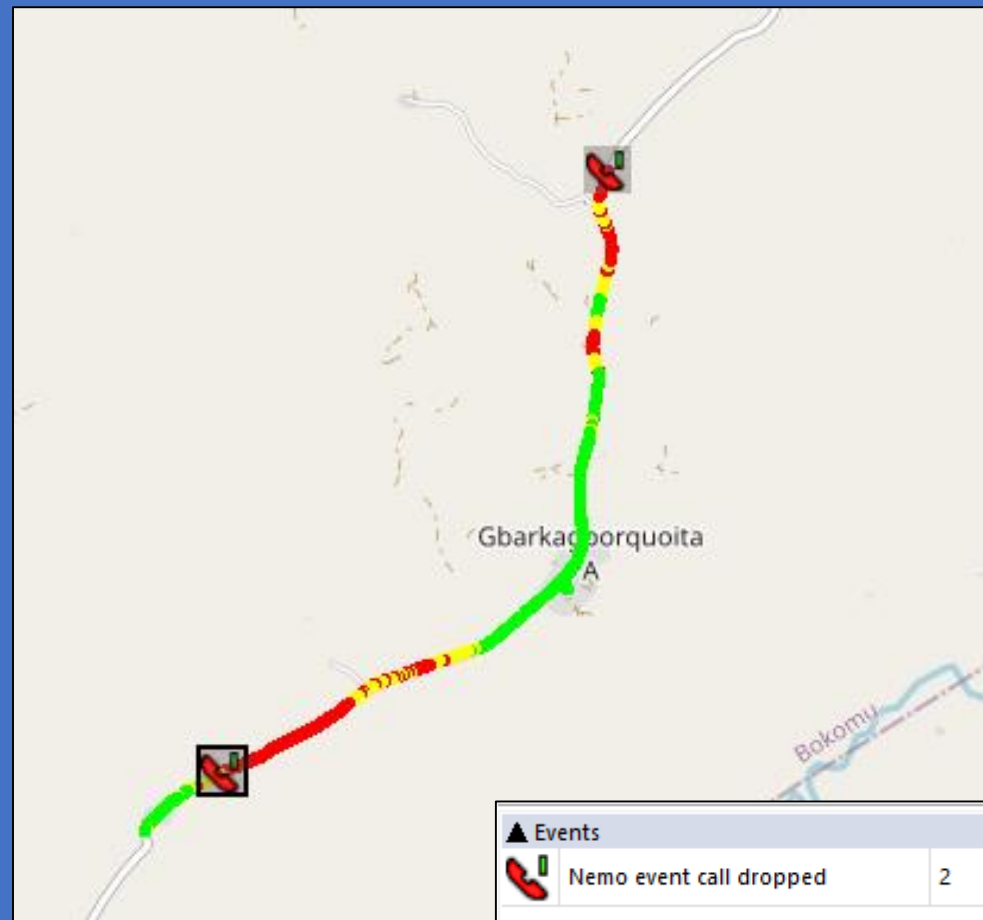
2 Calls dropped due to poor coverage.

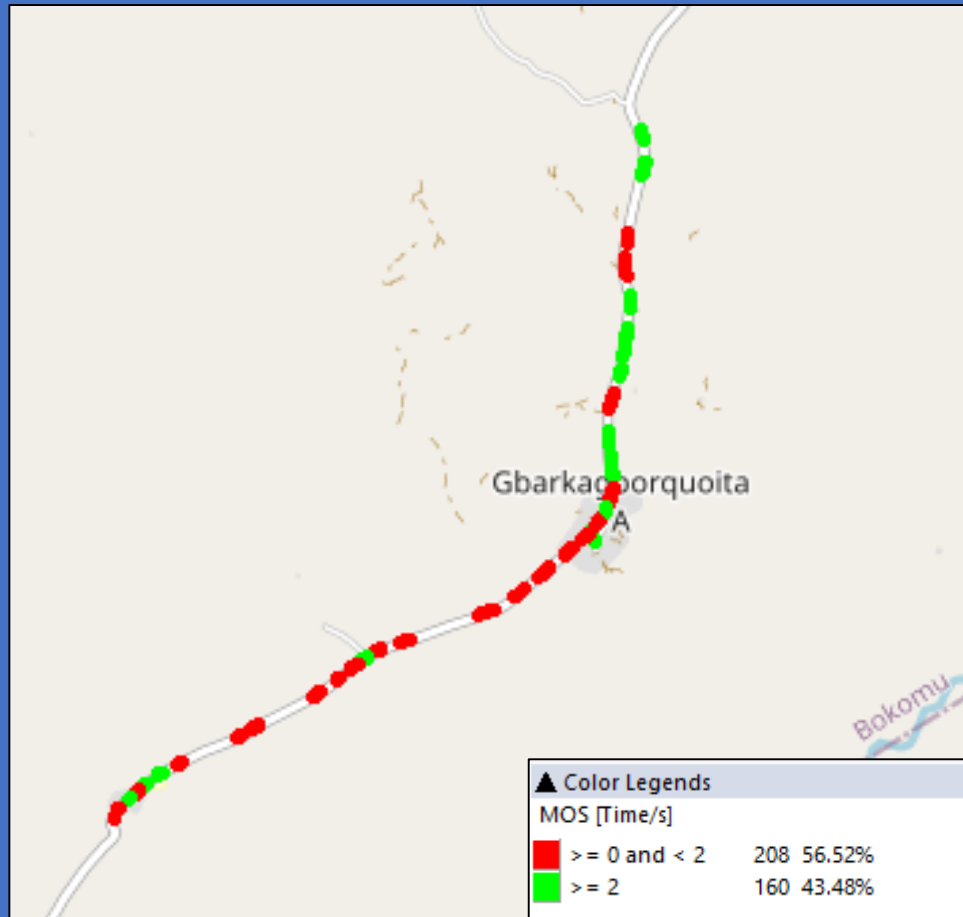
Voice Quality Score is below acceptable standards for most part of the test.

- Enable or check 2G EDGE parameter settings for internet connectivity.
- Check parameter settings to reduce call setup time to <15 sec.
- Check parameter settings to improve voice quality score.
- The site needs bi-annual maintenance.
- All metal tie wraps must to be replaced with rubber tie wraps, to meet telecommunications installation standard.
- All four legs of the tower need grounding.
- Bare grounding cables on the tower and in the cabinet must be changed to 72mm² coated grounding cable.
- Waveguide and jumper cables on RRUs need proper putty and tape for protection.
- Fabricated arm on the tower needs to be replace soon, else it will break, and the antenna will fall.
- Free hanging cables on the tower need cable holder.
- Grounding cables on fence should be 25mm² or 35mm² coated.
- Grounding test needs to be conducted for grounding system at the site.

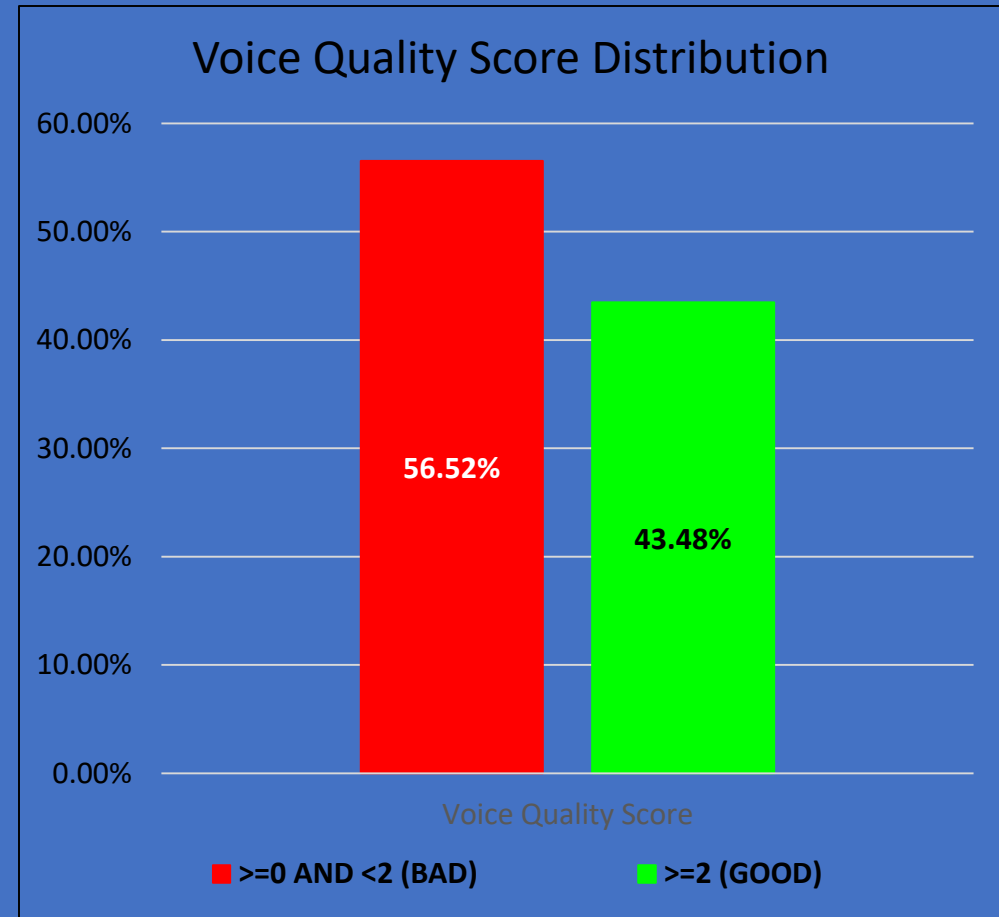
Almost 60% of the voice calls had poor voice quality

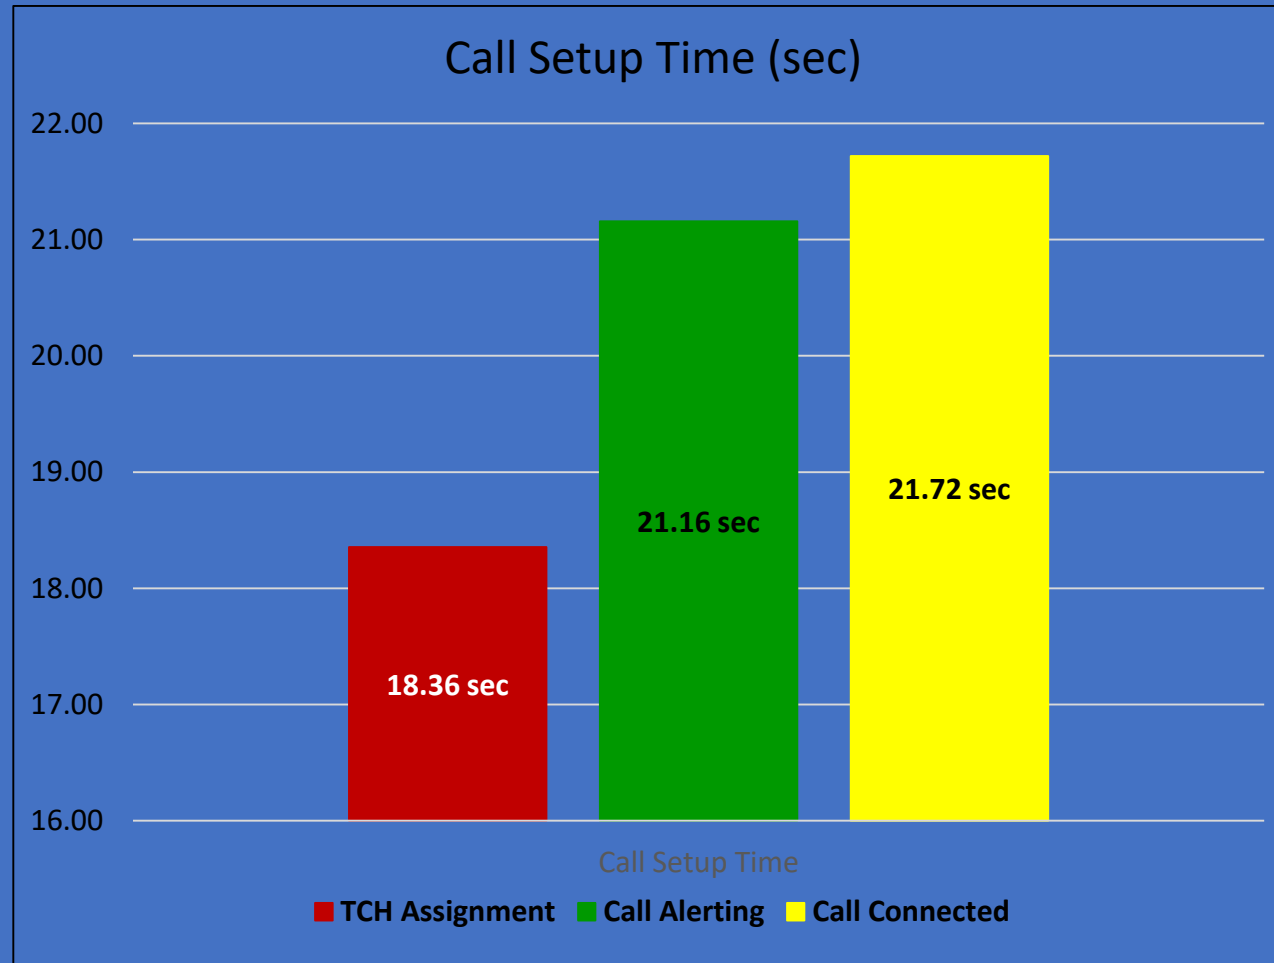
Average Call Setup Time is more than 2 times the normal (8 sec)

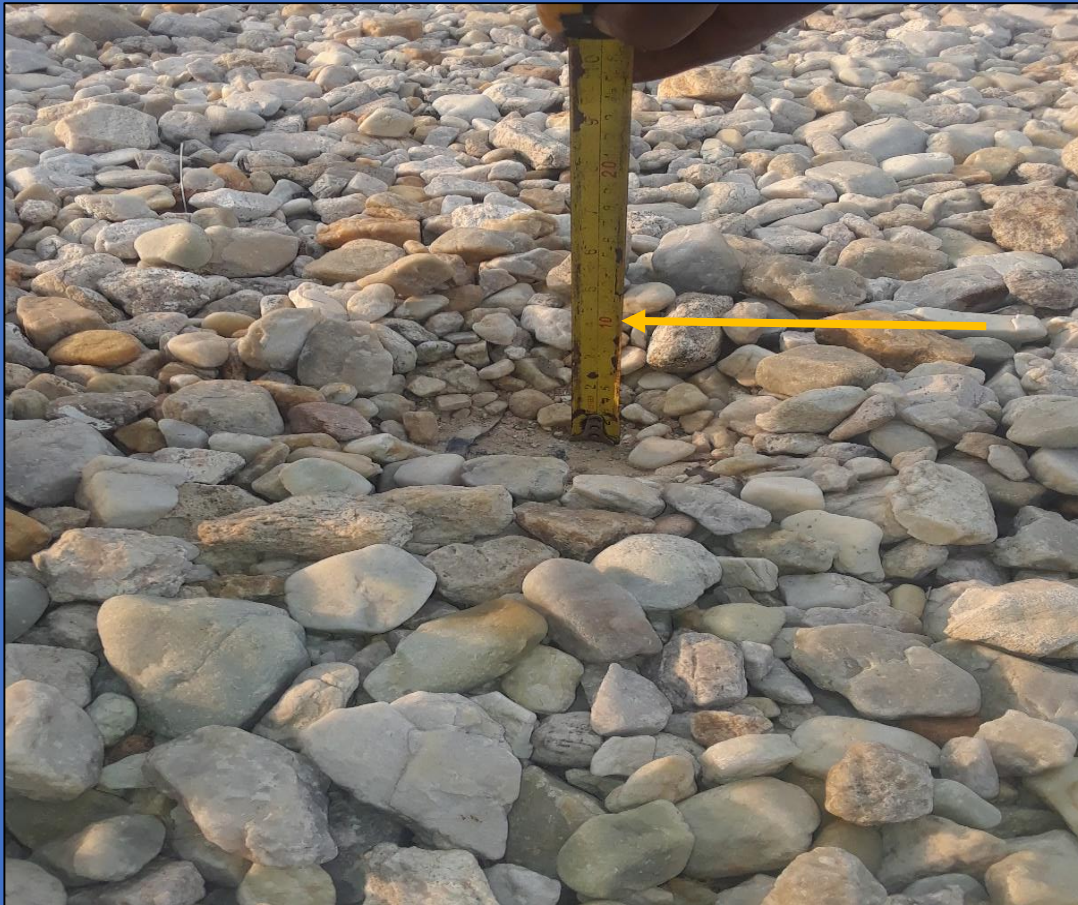
Gravel in the fence does not meet the 10cm standard.

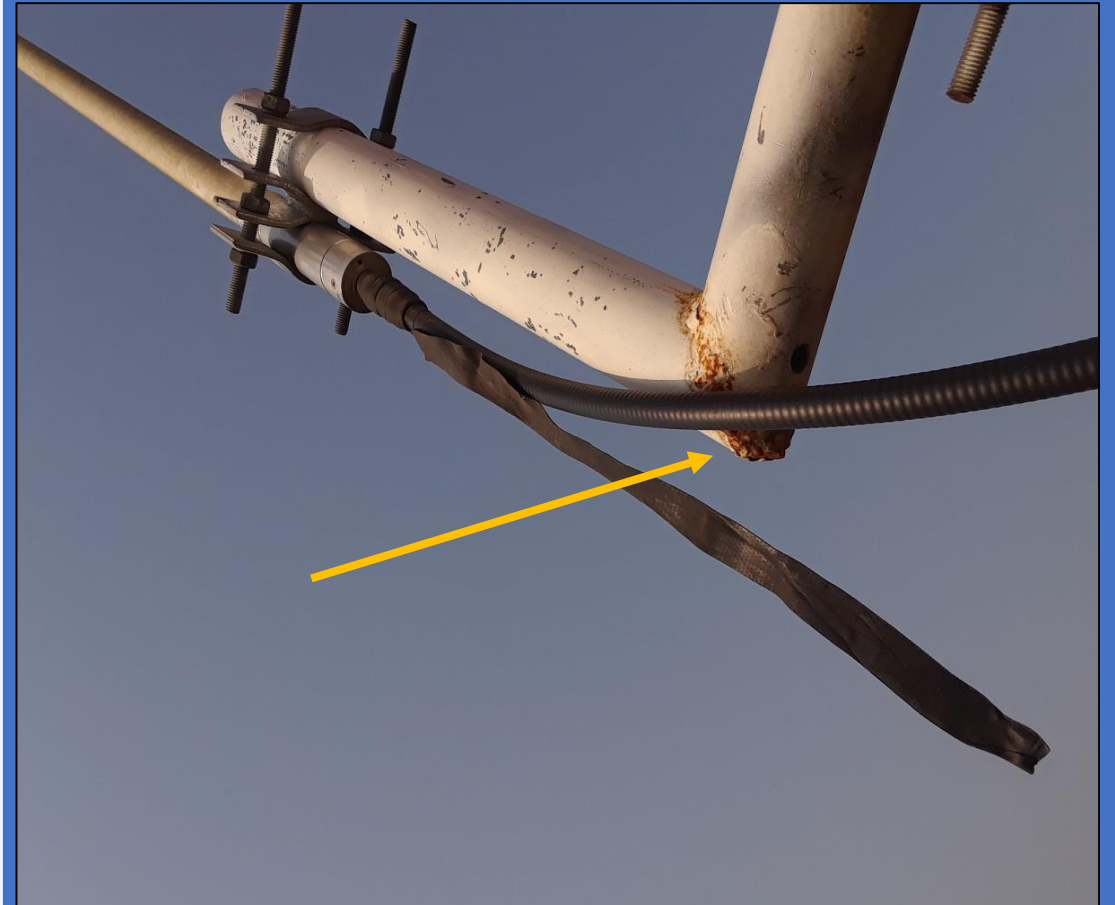
The Fabricated arm which hosts the antenna is rusty at joint.

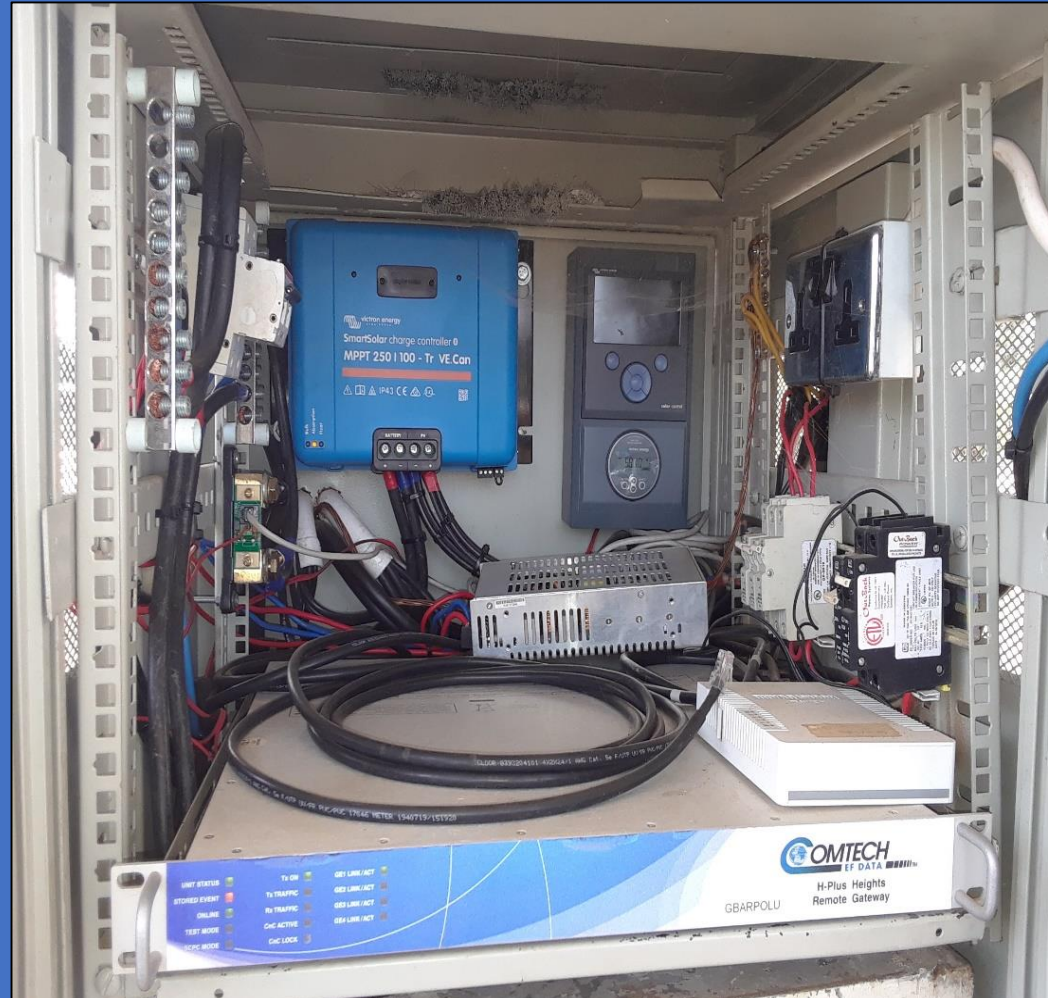
Cables in the cabinet are scattered and not properly laid.

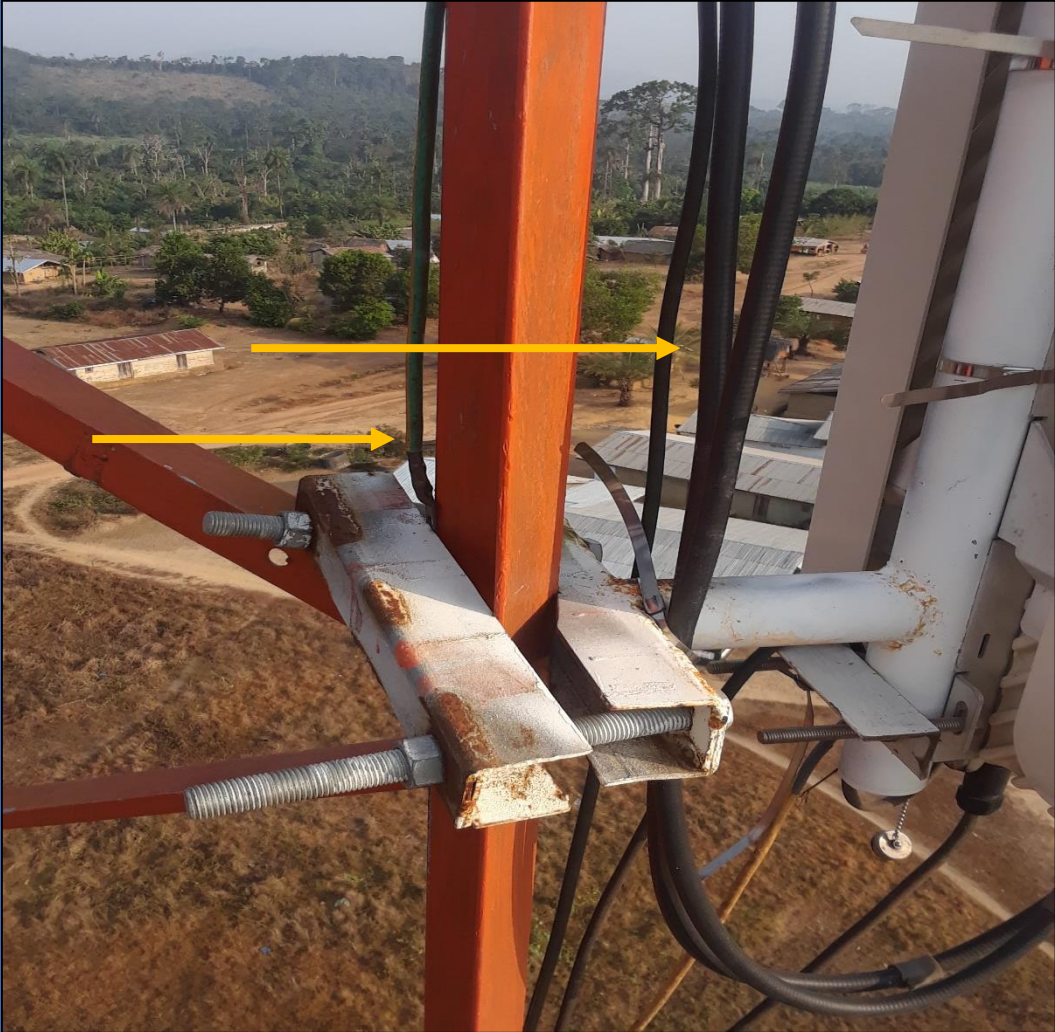
The jumper cables are scattered on the tower from the RRUs.

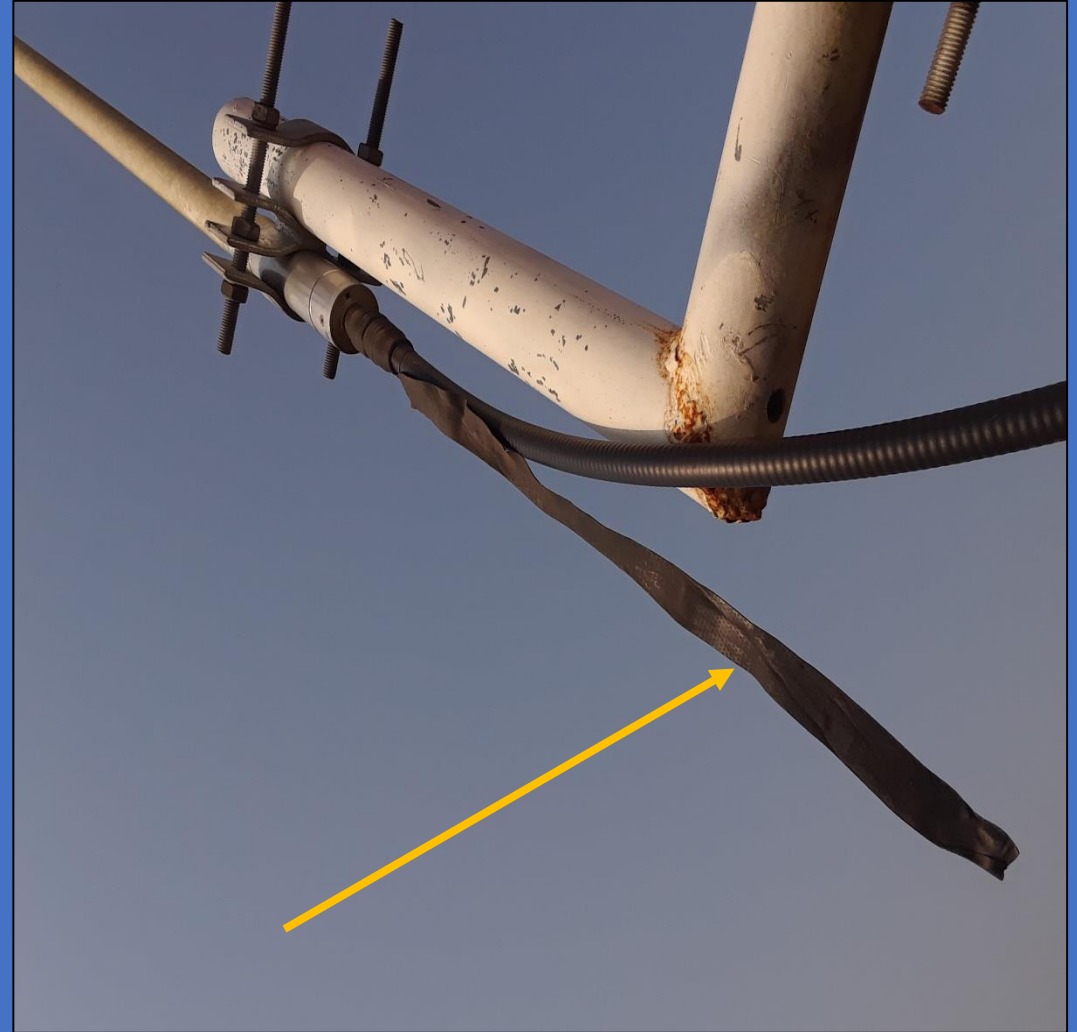
Improper taping of jumper cable from the antenna.

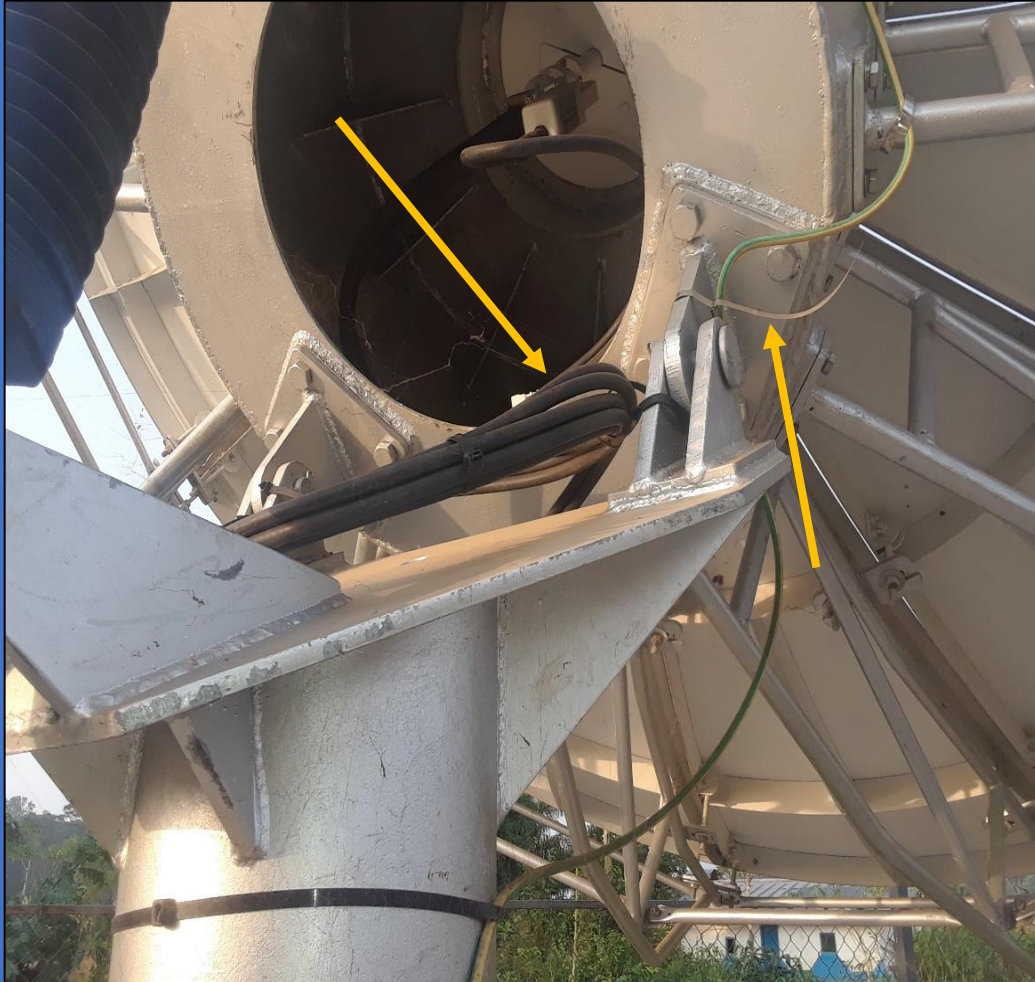
The IF cable loop is more than one and tie wraps are not cut.

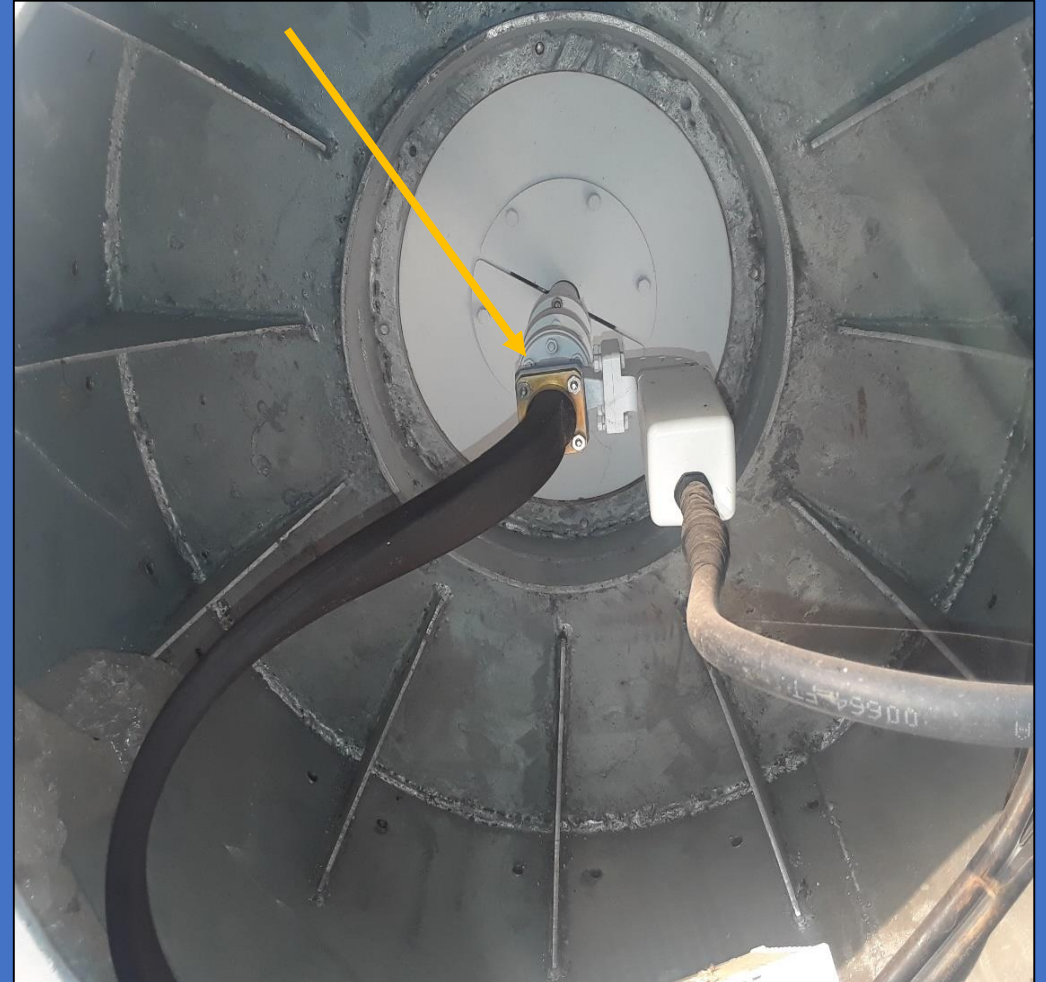
The waveguide is not protected with putty and tape.

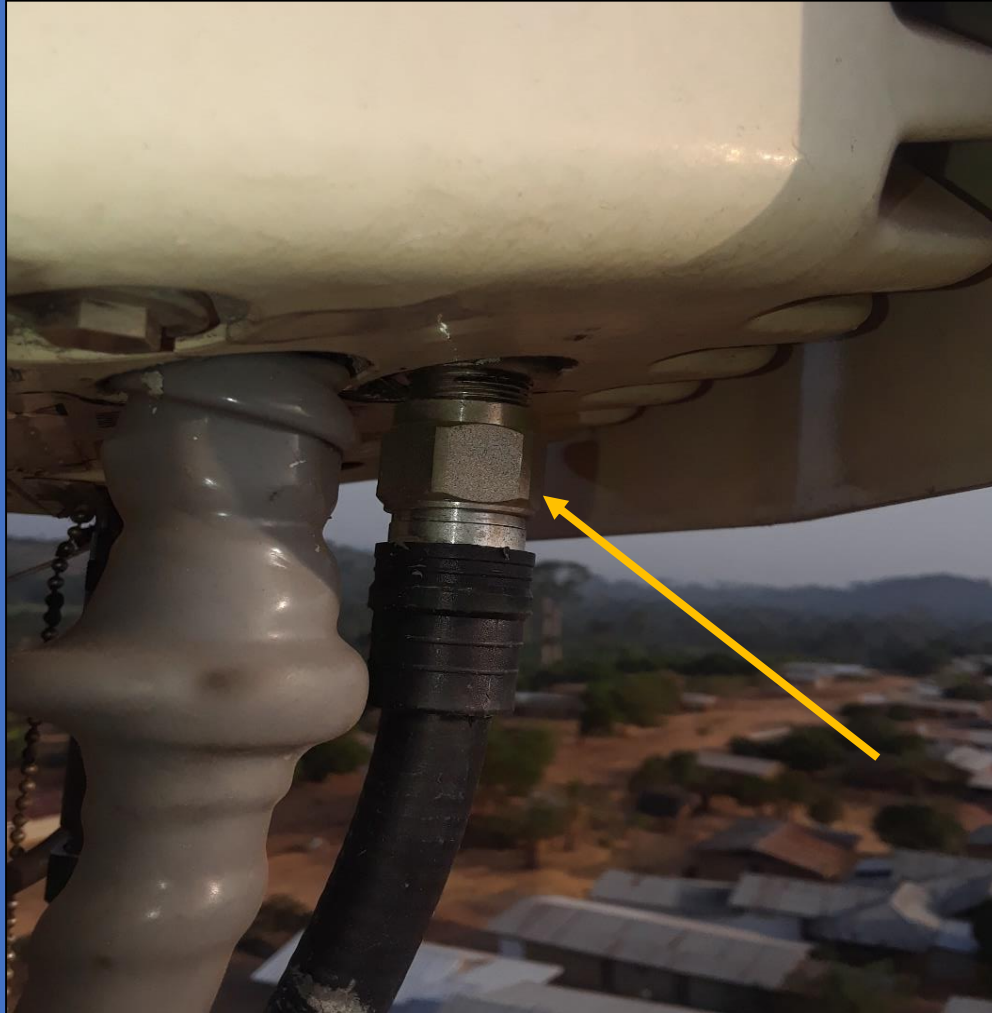
The IF cable connected to the MODEM on tower is not protected with putty and tape.

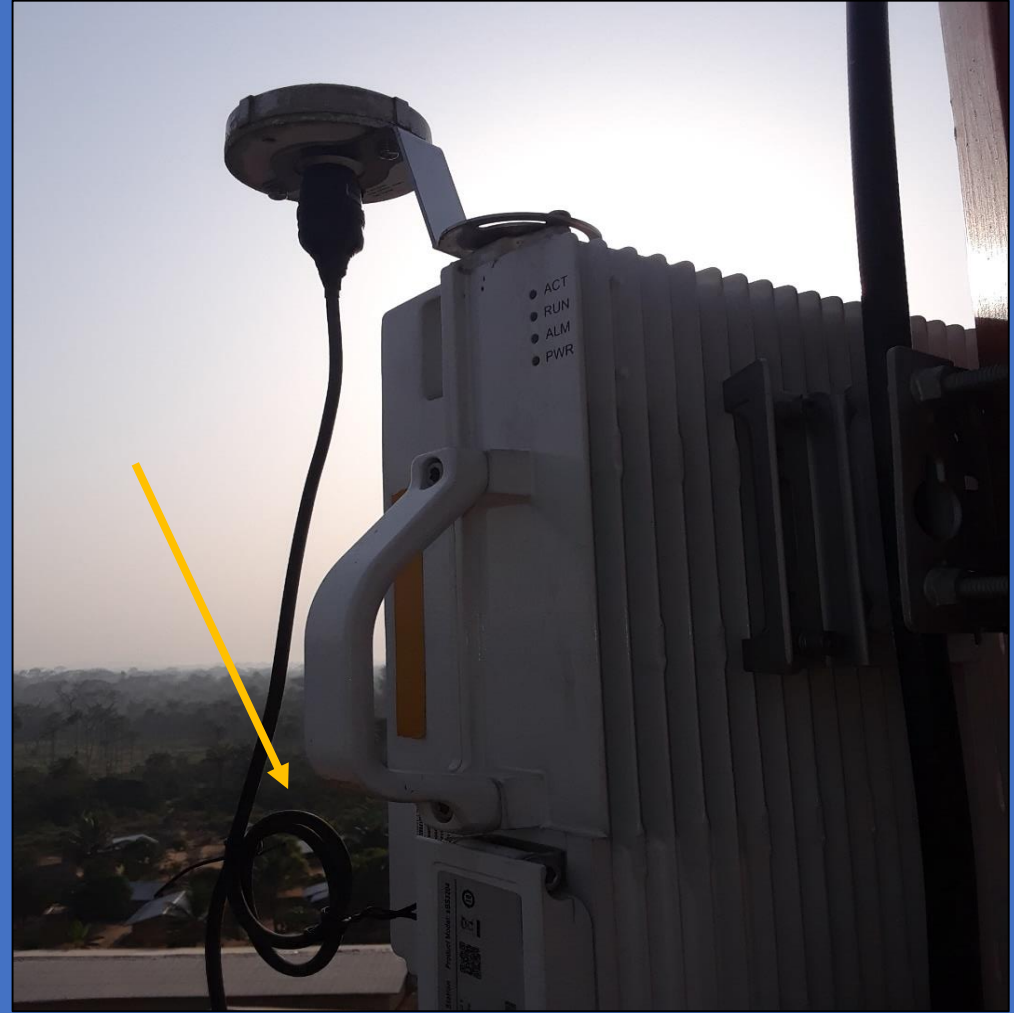
The GPS cable loop is more than one.

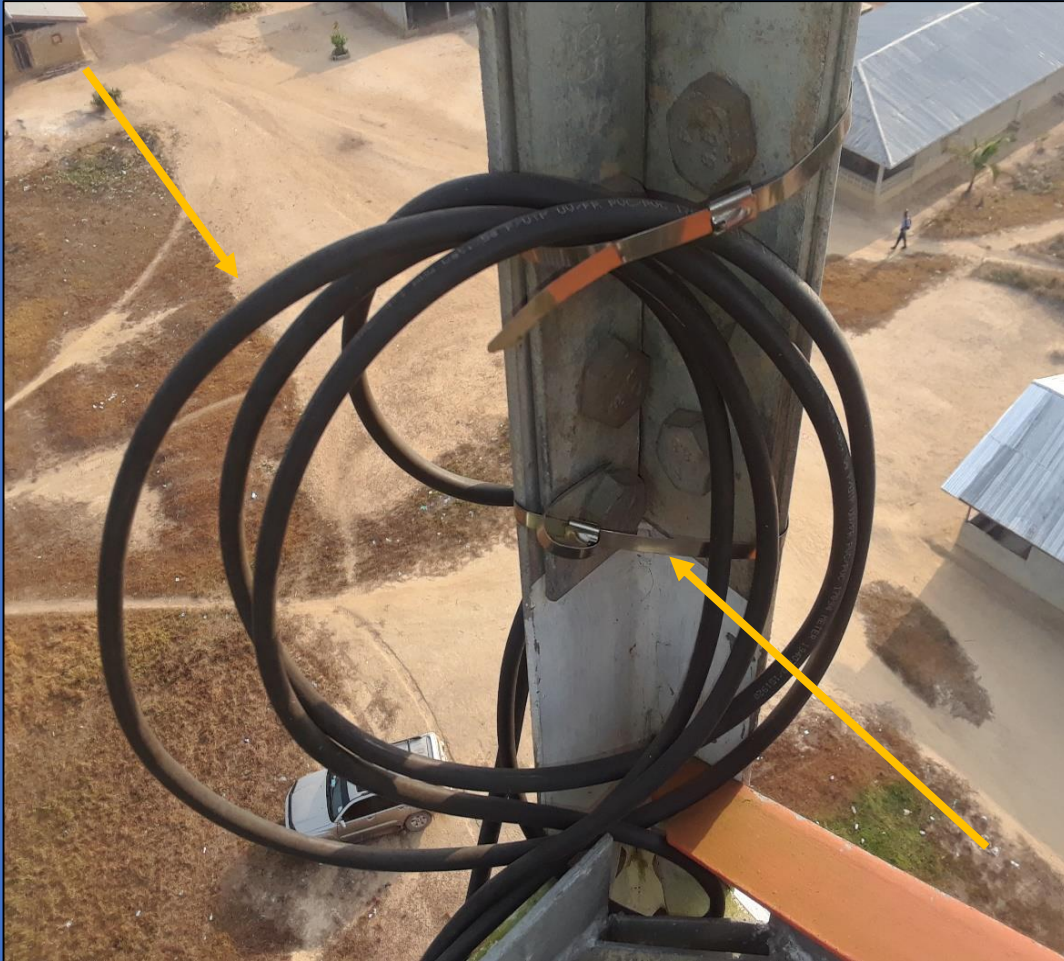
The IF cable loop on the tower is more than one; The tie wraps used are not of telecommunications standard.

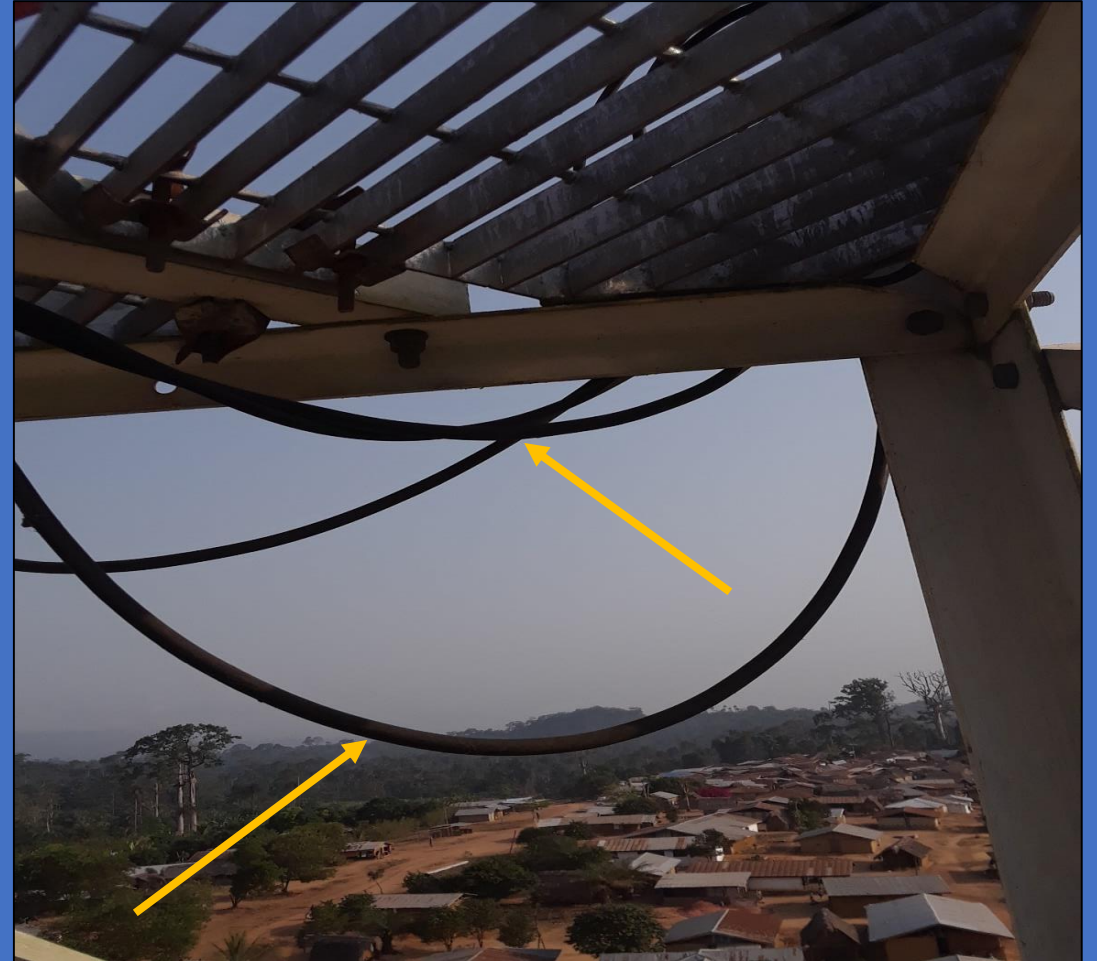
The jumper cables from RRUs to antennas are run improperly.

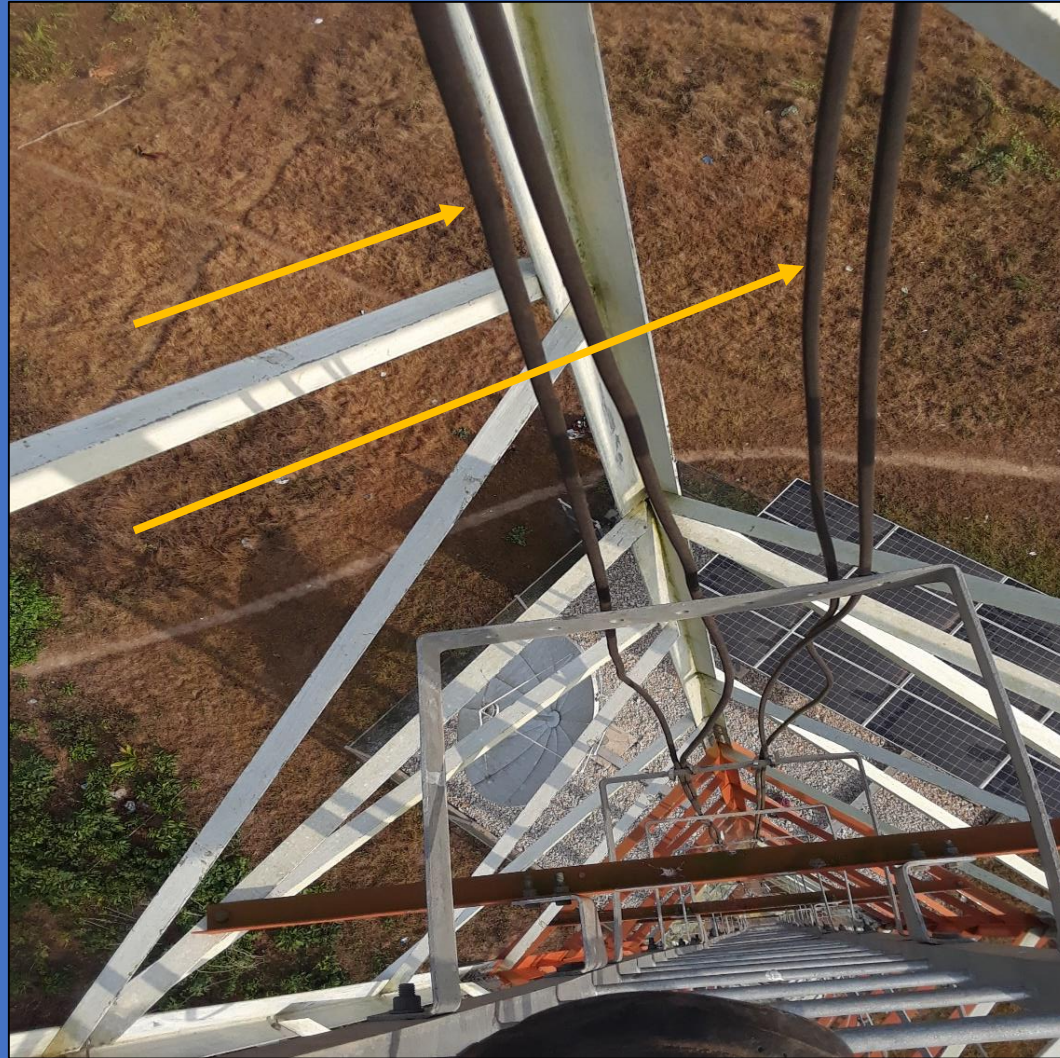
The IF cables on the tower are freely hanging.
