ABSOLUTE SOLUTIONS INC.

UNIVERSAL ACCESS FUND RTP SITE VALIDATION & ACCEPTANCE REPORT

8 February 2021

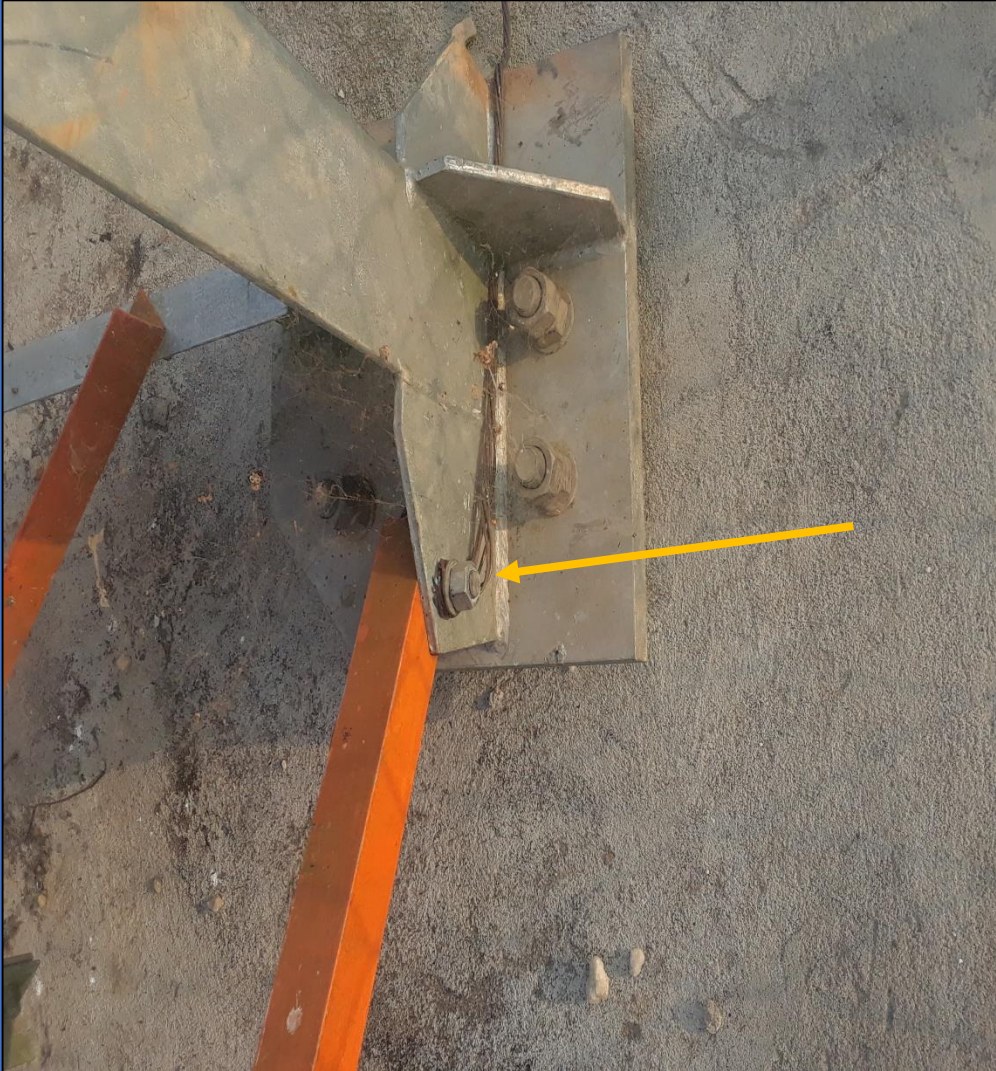
Grounding on tower leg has no cable lug.

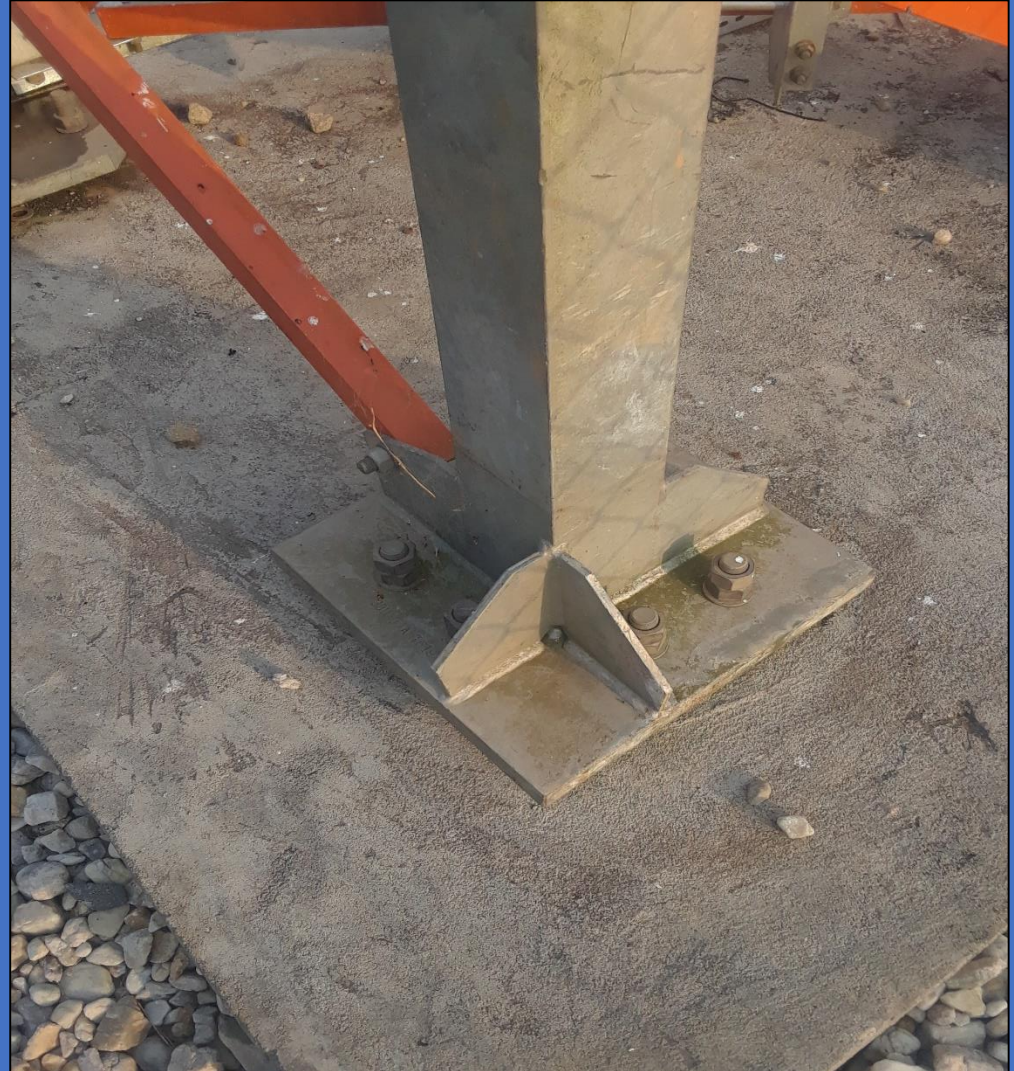
Only two of the four tower legs are grounded.

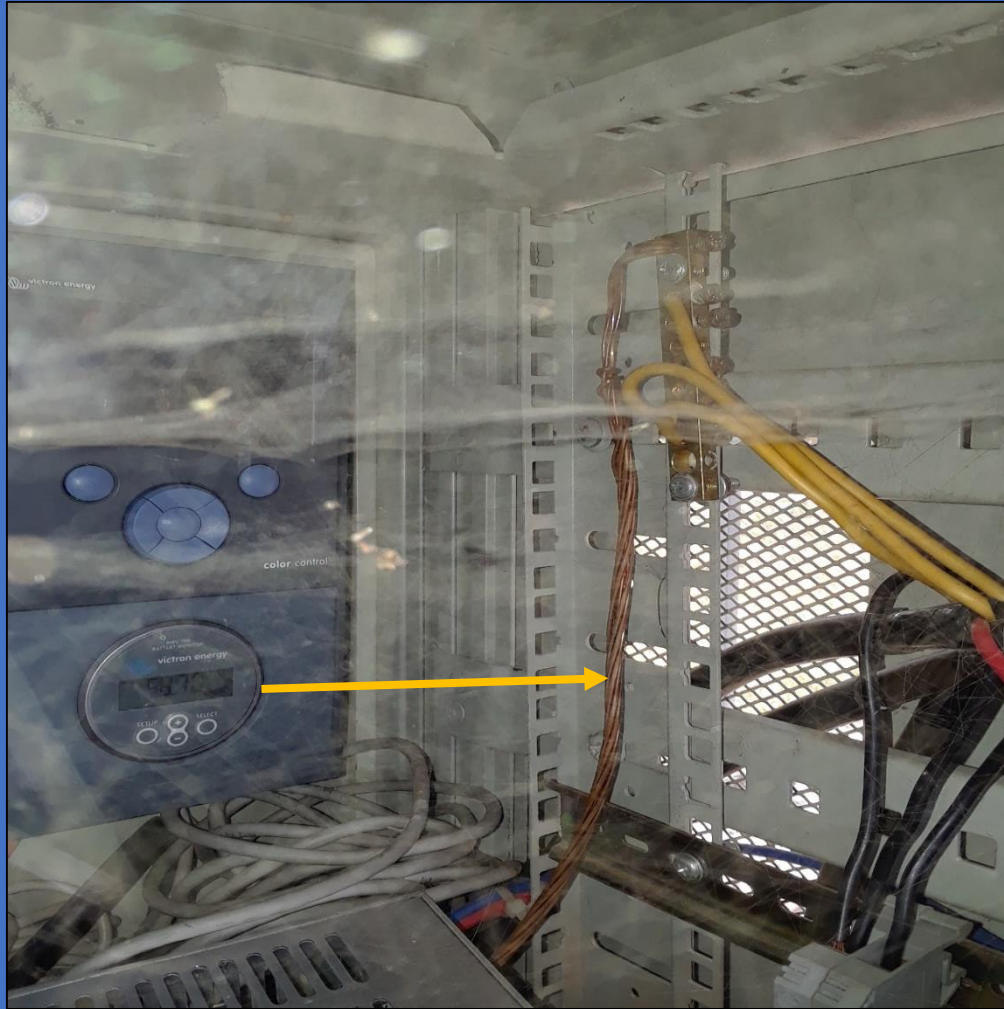
Grounding cable in the cabinet is bare.

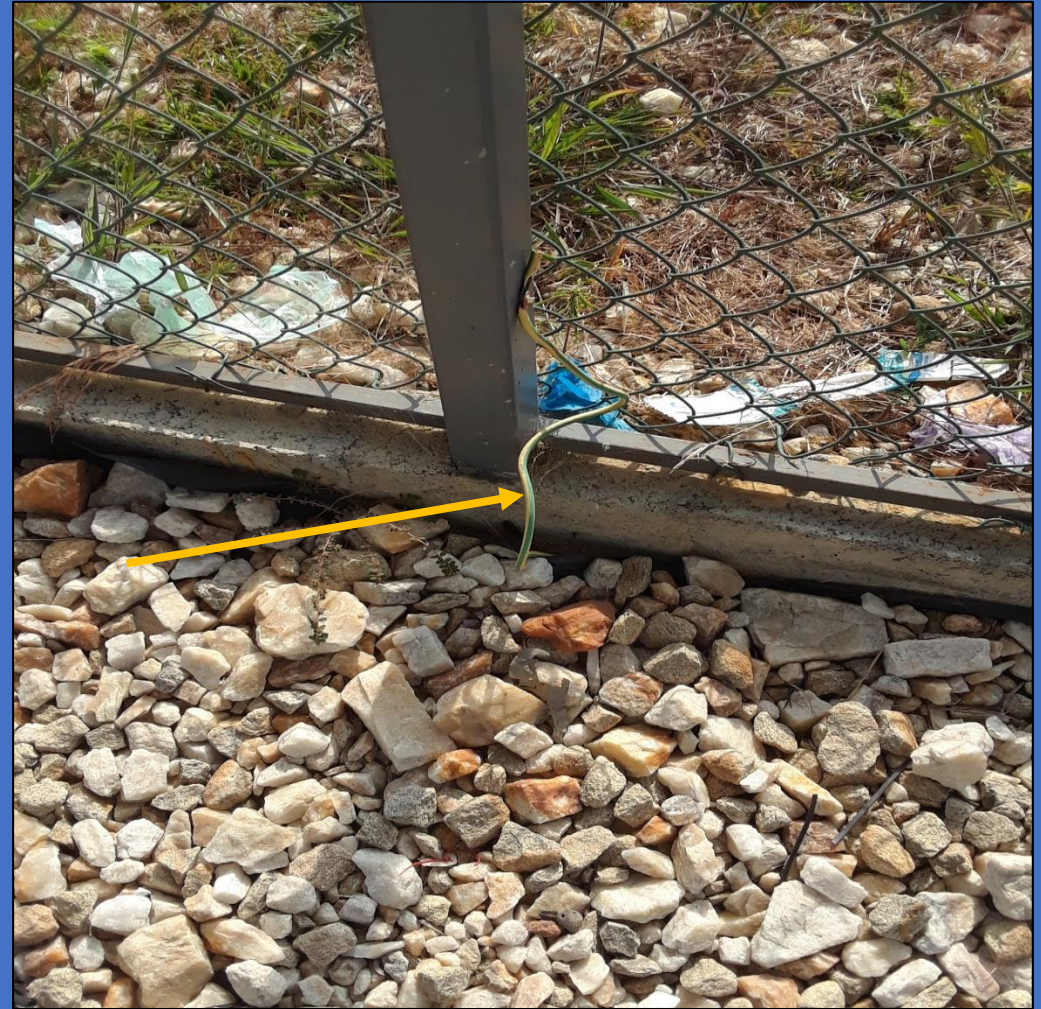
Grounding cable for the fence is 16mm², not the standard for outdoor.

- Enable or check 2G EDGE parameter settings for internet connectivity.
- Check parameter settings to reduce call setup time to <15 sec.
- Check parameter settings to improve voice quality score.
- The site needs bi-annual maintenance.
- All metal tie wraps must to be replaced with rubber tie wraps, to meet telecommunications installation standard.
- All four legs of the tower need grounding.
- Bare grounding cables on the tower and in the cabinet must be changed to 72mm² coated grounding cable.
- Waveguide and jumper cables on RRUs need proper putty and tape for protection.
- Fabricated arm on the tower needs to be replace soon, else it will break, and the antenna will fall.
- Free hanging cables on the tower need cable holder.
- Grounding cables on fence should be 25mm² or 35mm² coated.
- Grounding test needs to be conducted for grounding system at the site.

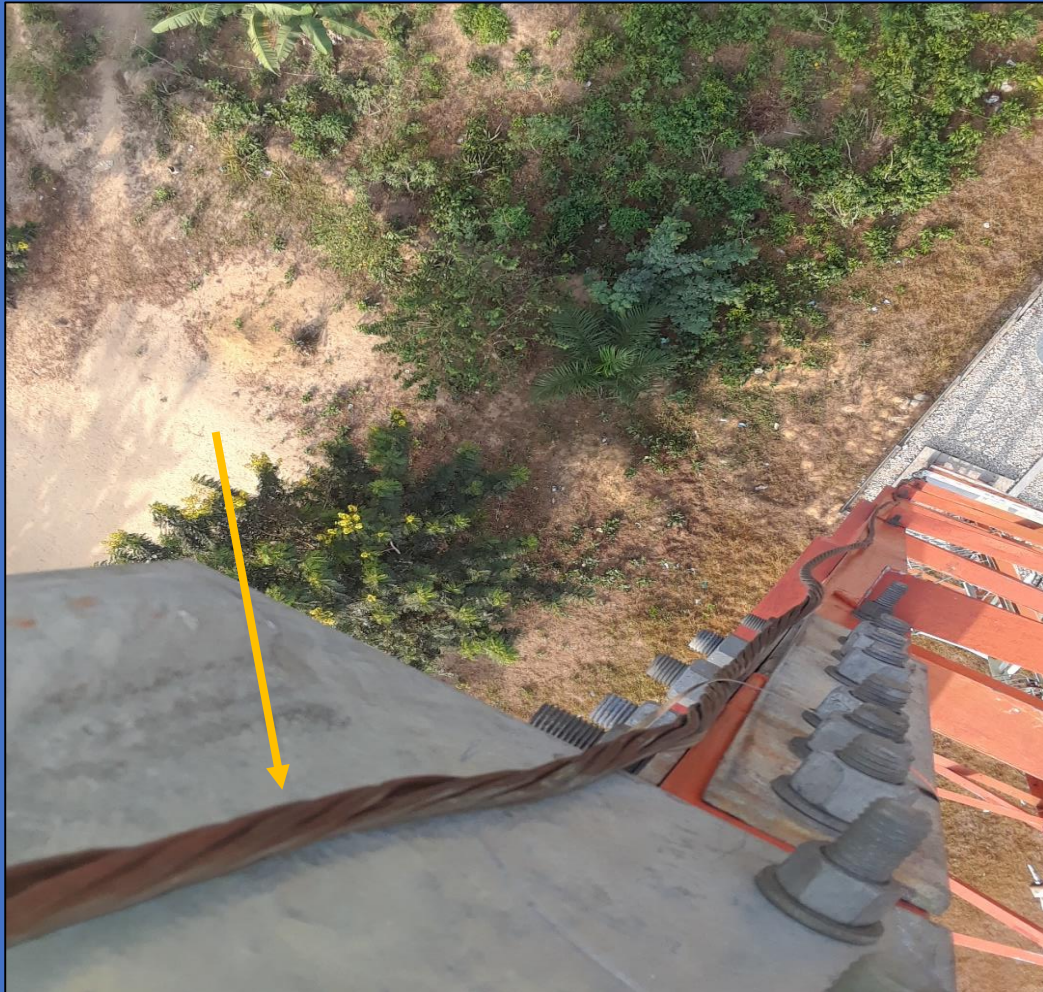
Grounding cable on the tower is bare.

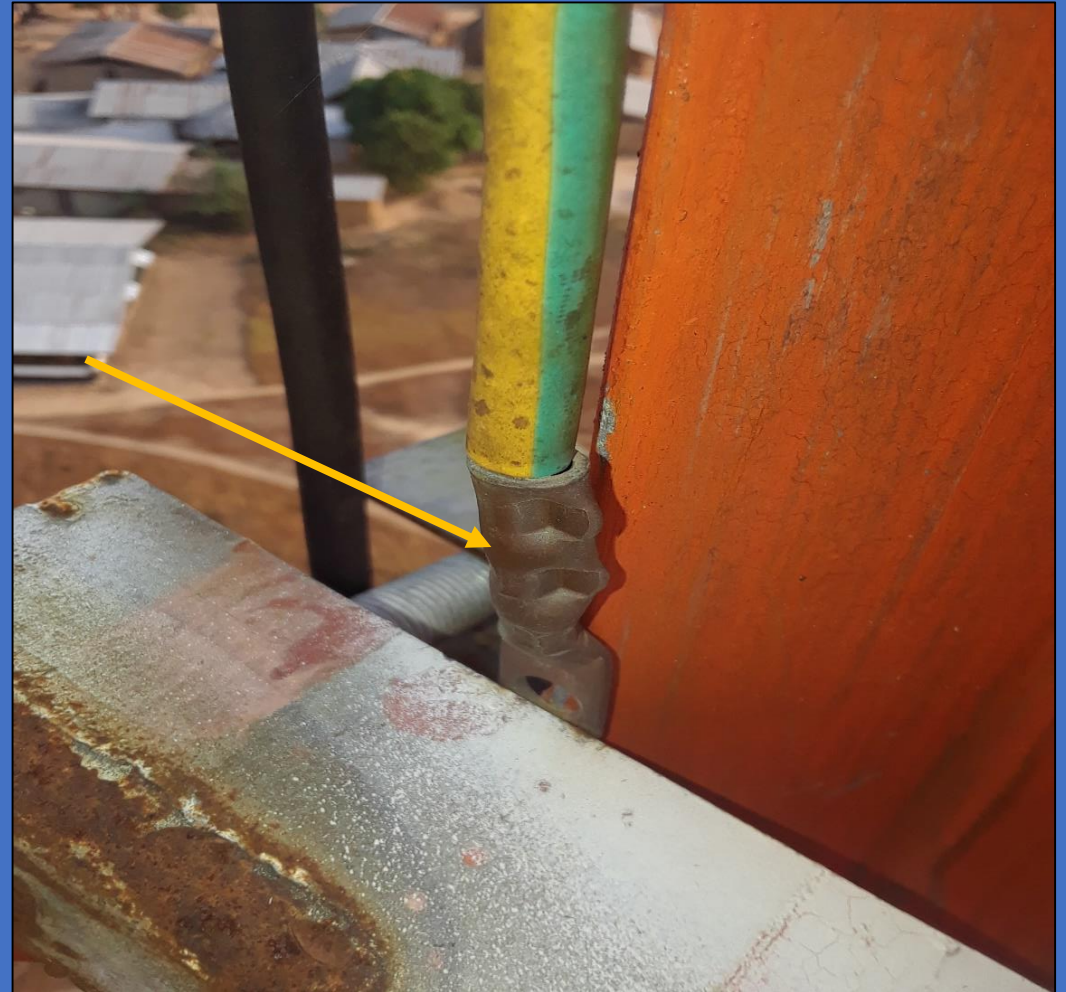
The Grounding cable is not terminated to a bus-bar.
The tower has no bus-bar.

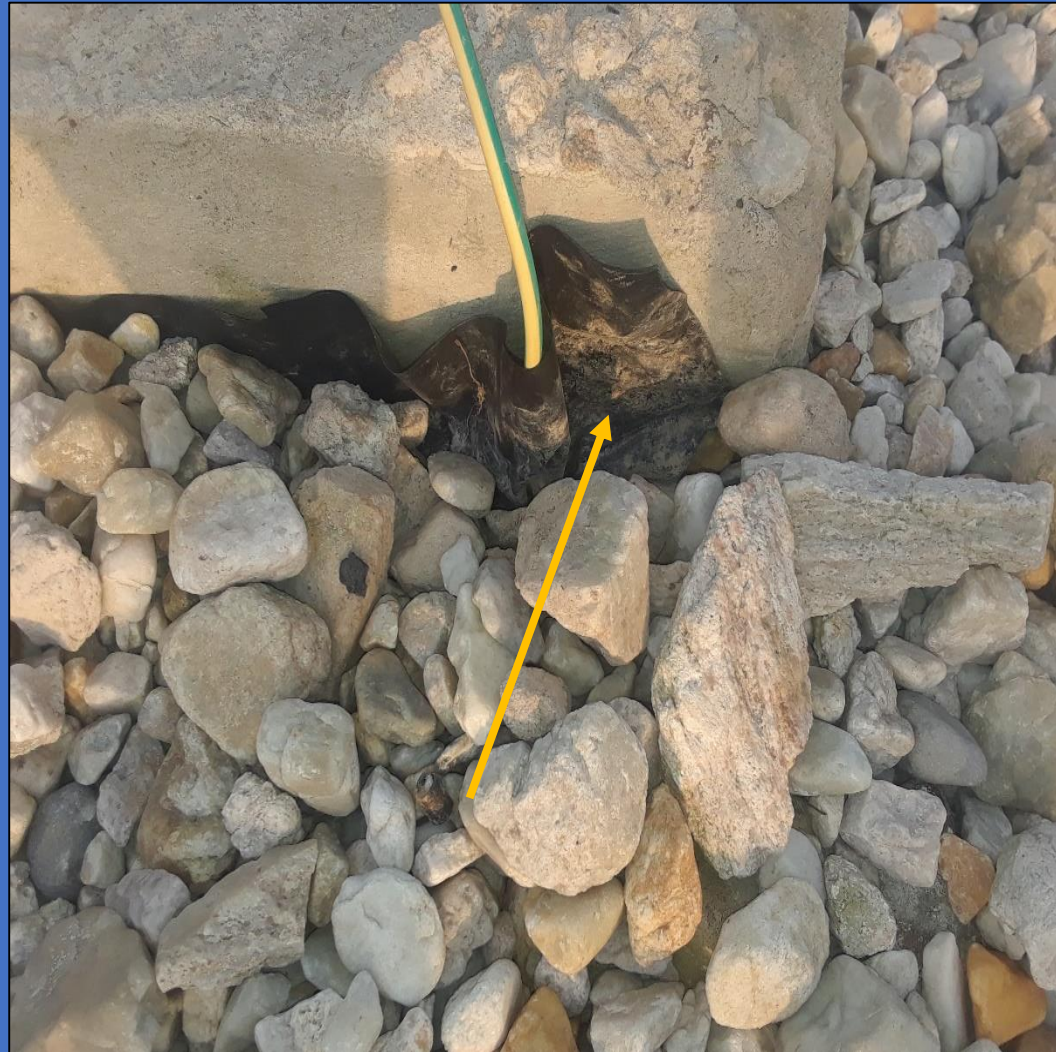
The plastic should not be visible.
