ABSOLUTE SOLUTIONS INC.

UNIVERSAL ACCESS FUND RTP
SITE VALIDATION & ACCEPTANCE
REPORT - PARLUKEN

15 February 2021

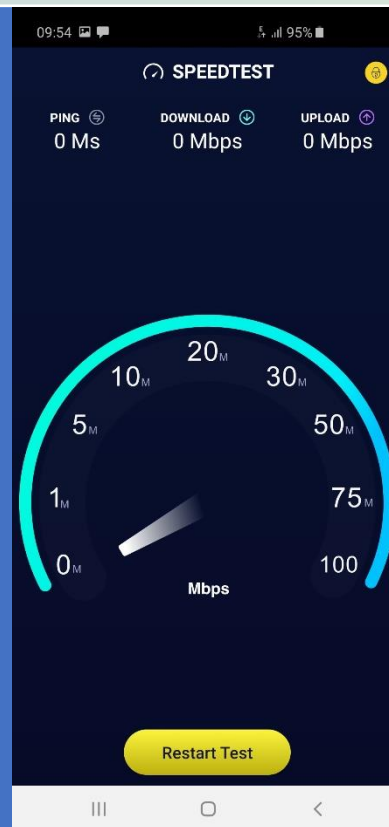
SPEED TEST RESULT

Ping: 0 ms
DL: 0 Mbps
UL: 0 Mbps

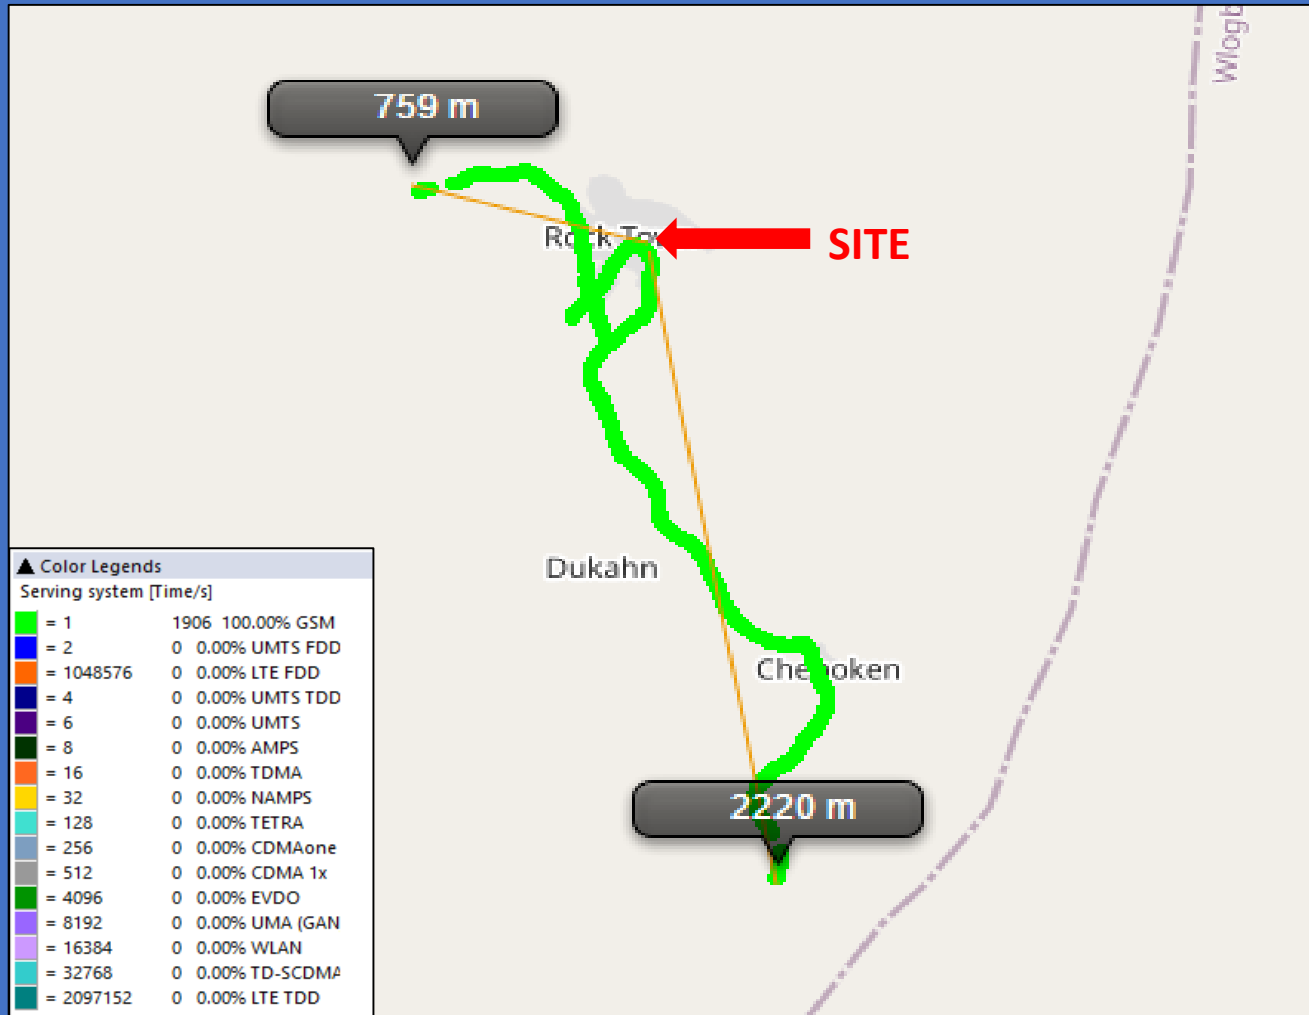
The site coverage radius is about maximum 2.2 km with 100% in 2G network.

- Enable or check 2G EDGE parameter settings for internet connectivity.
- Check parameter settings to reduce call setup time to <15 sec.
- Optimized site RF antenna and/or check parameter settings to improve cell coverage radius to 5 km.

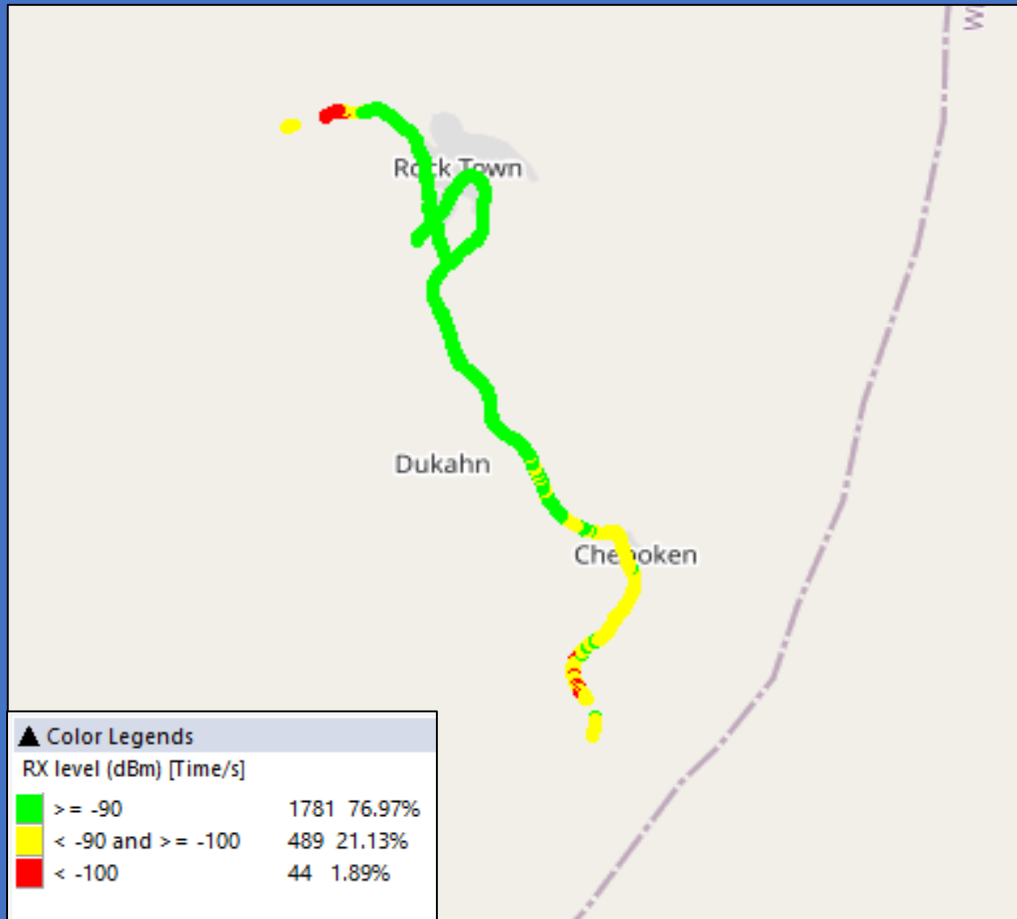
GSM coverage of the site is normal.

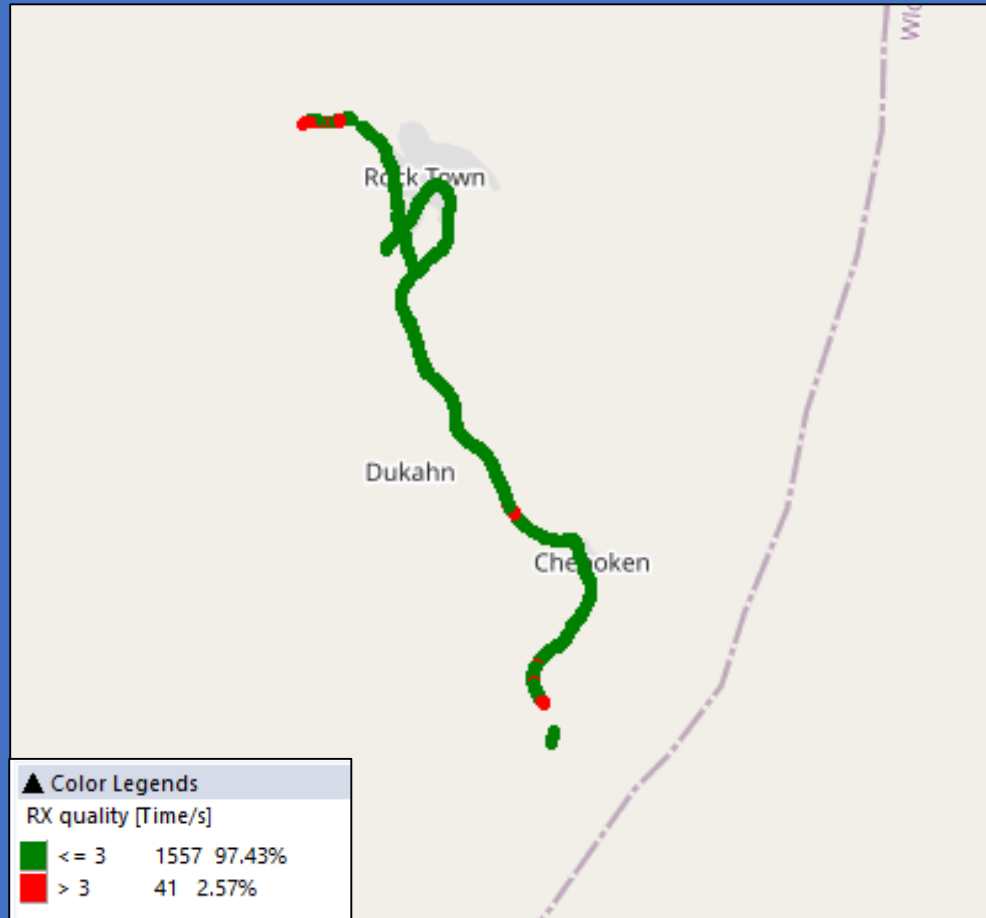
The site signal quality is normal.

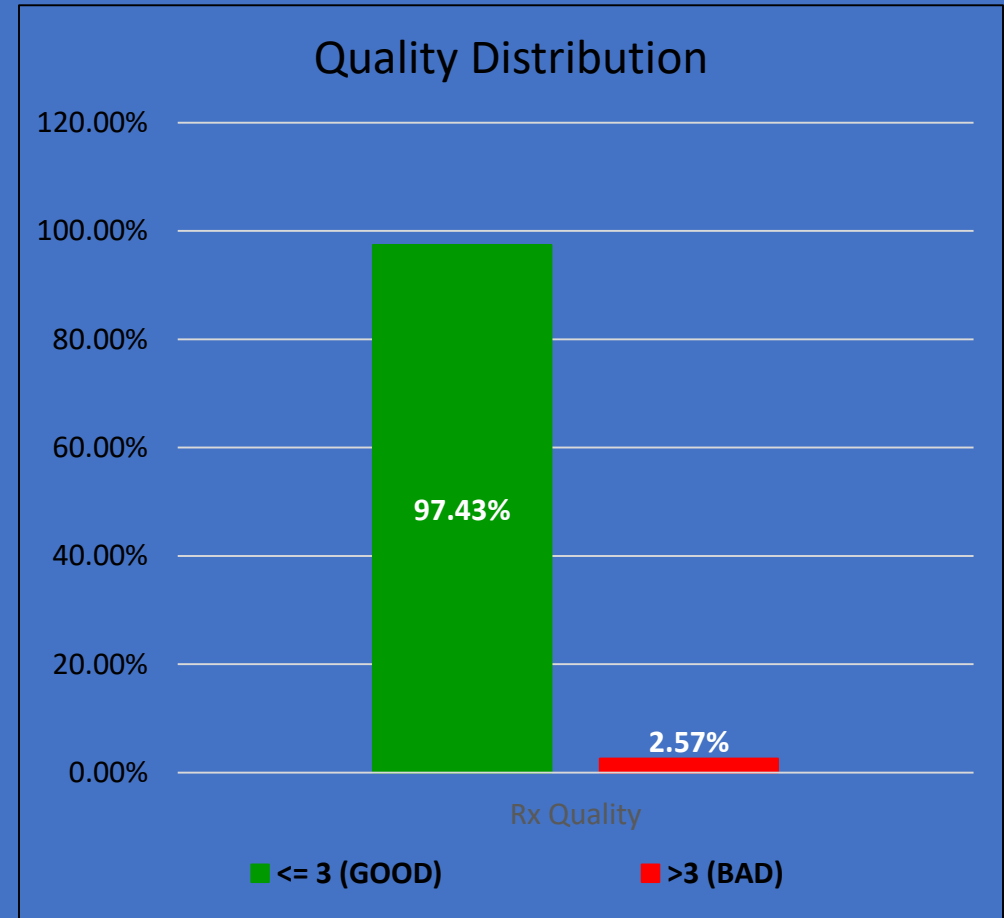
Signal Quality distribution. Bad quality originates from degradation in coverage.

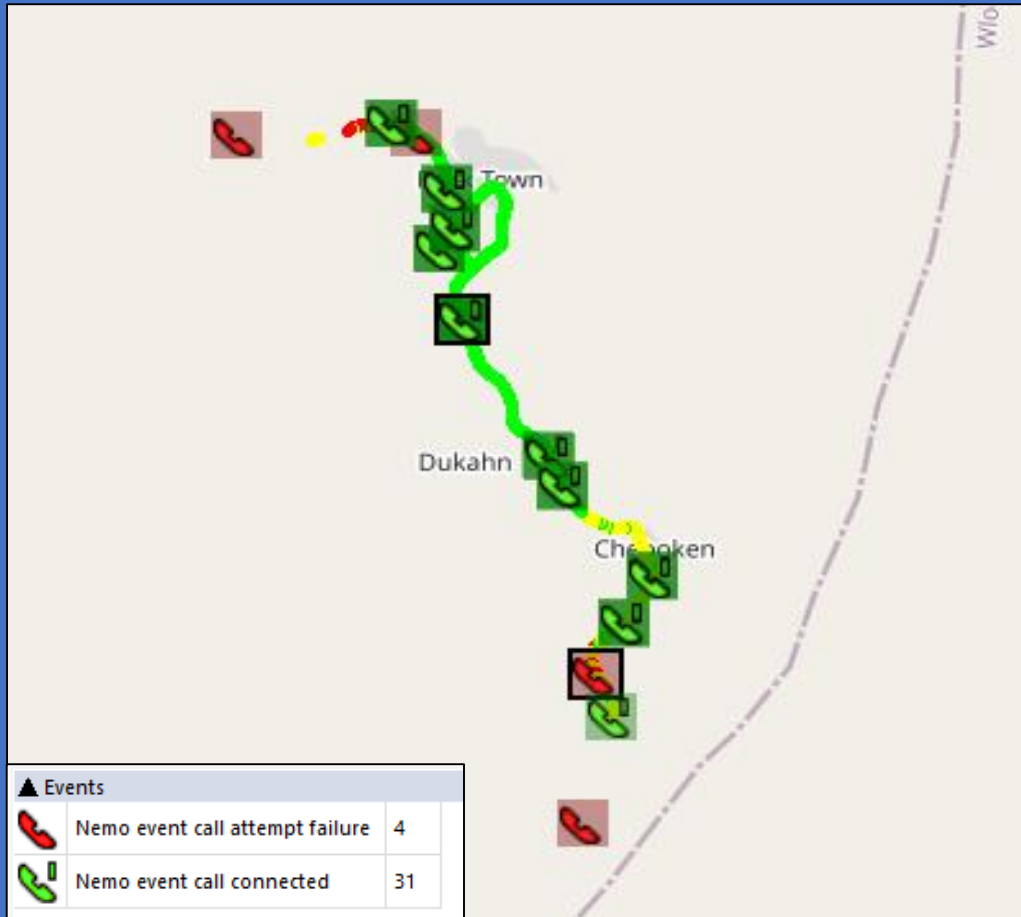
4 of the 35 calls failed; caused by weak signal level.

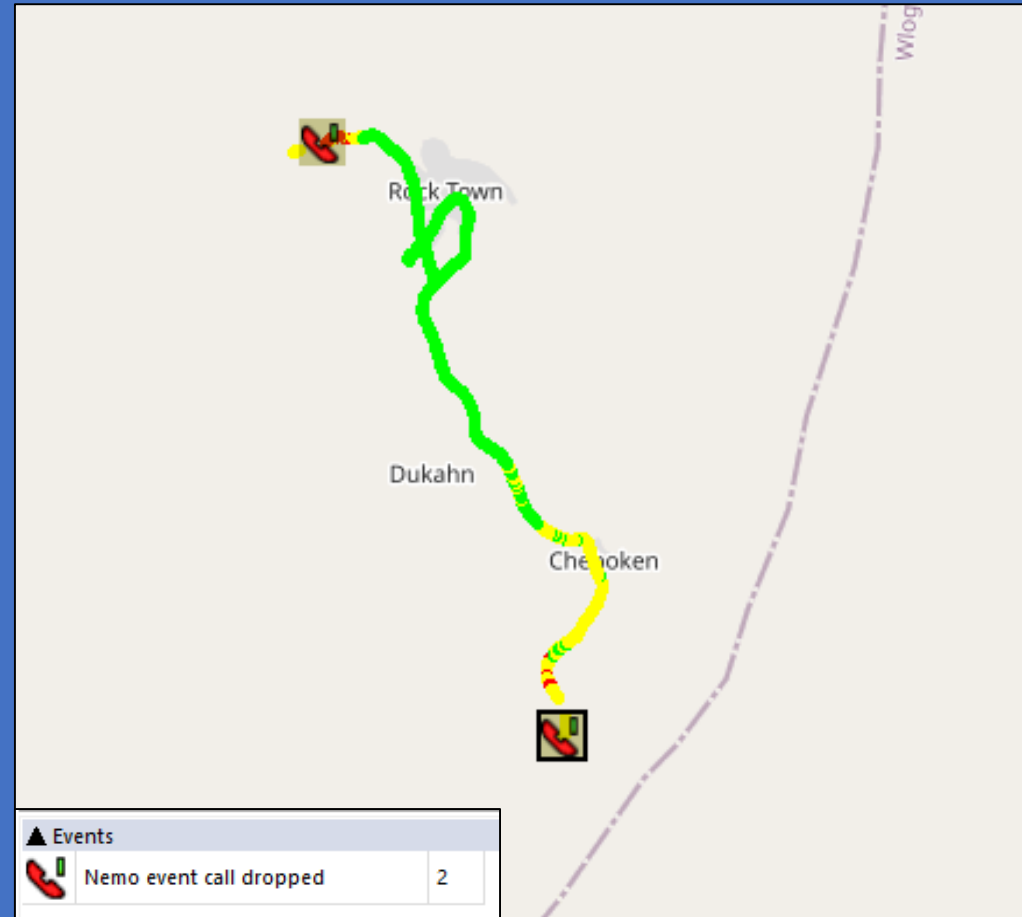
2 calls dropped due to poor coverage.

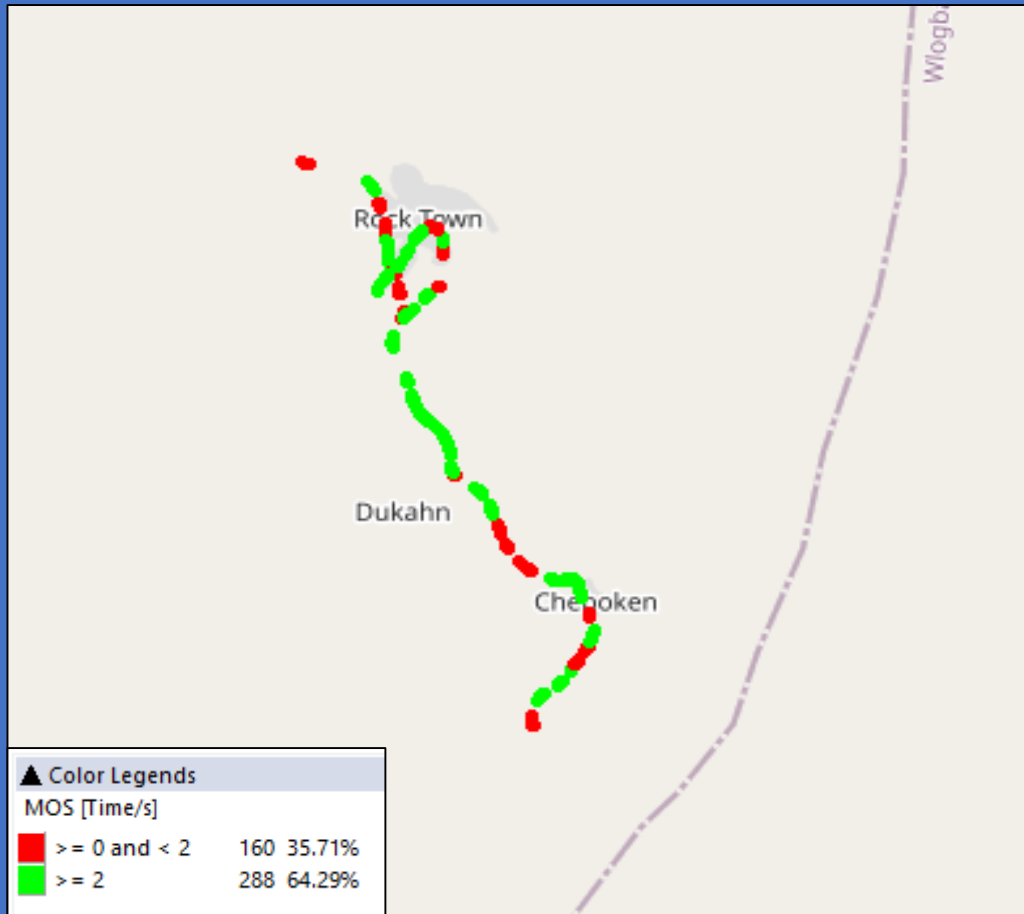
Voice Quality Score is above acceptable standards for most part of the test.

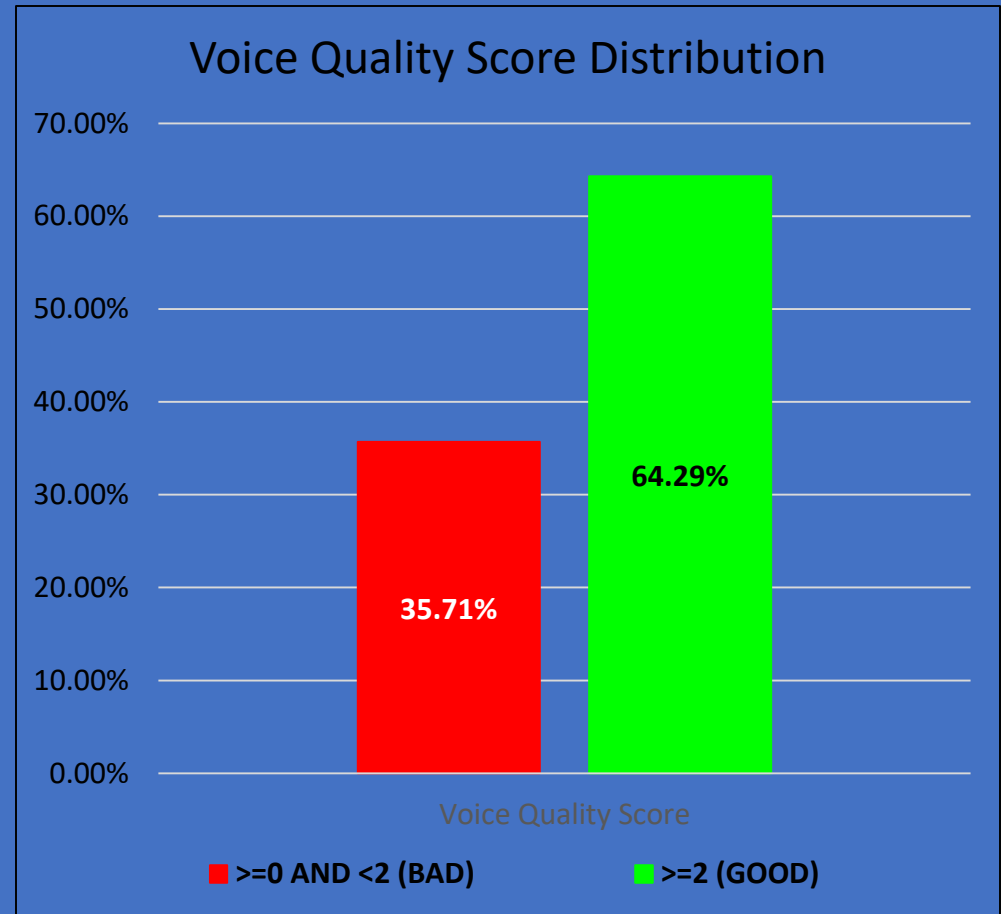
About 64% of the voice calls had good voice quality

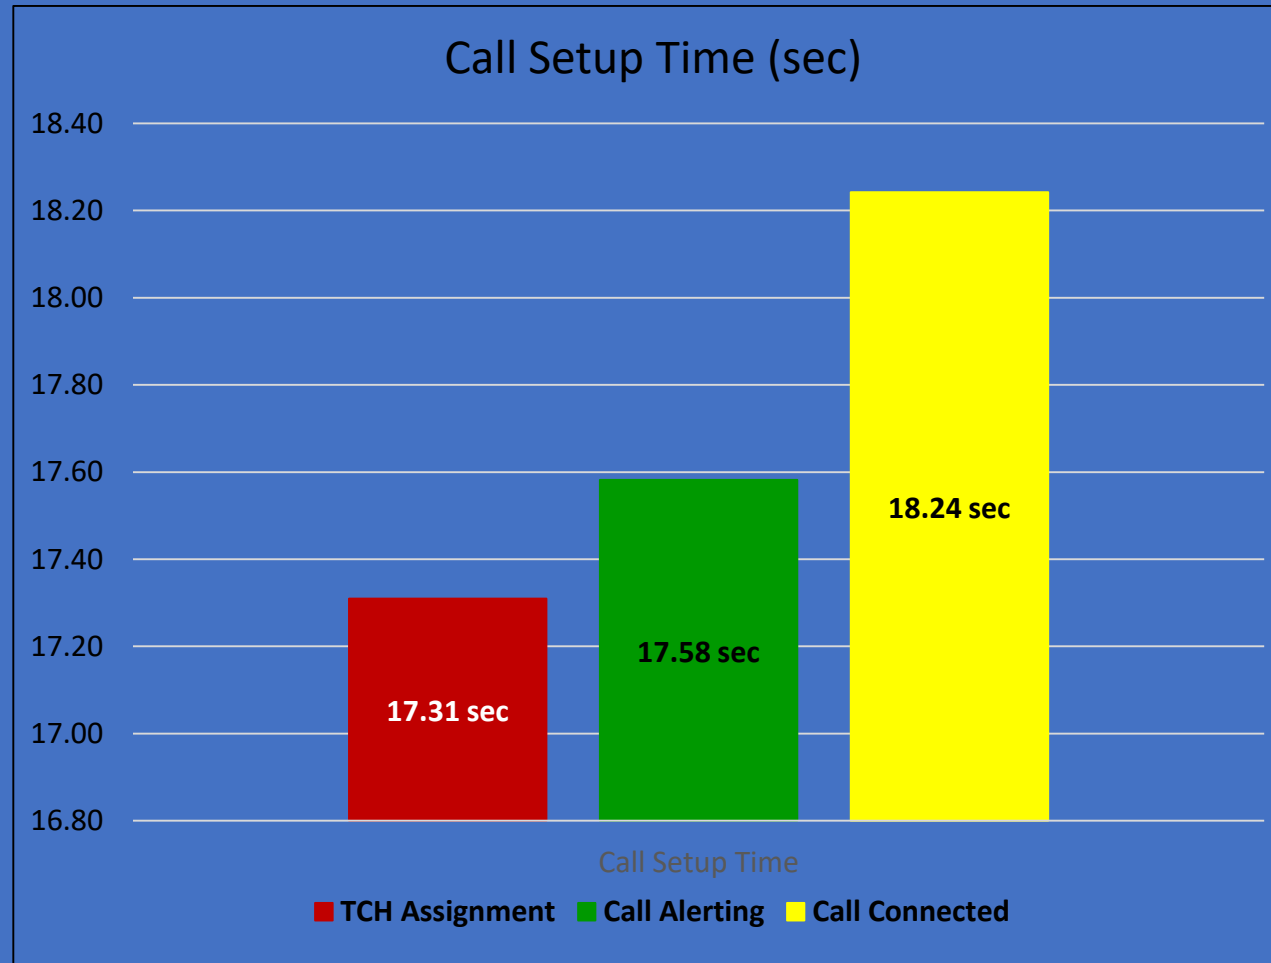
Average Call Setup Time is more than 2 times the normal (8 sec)

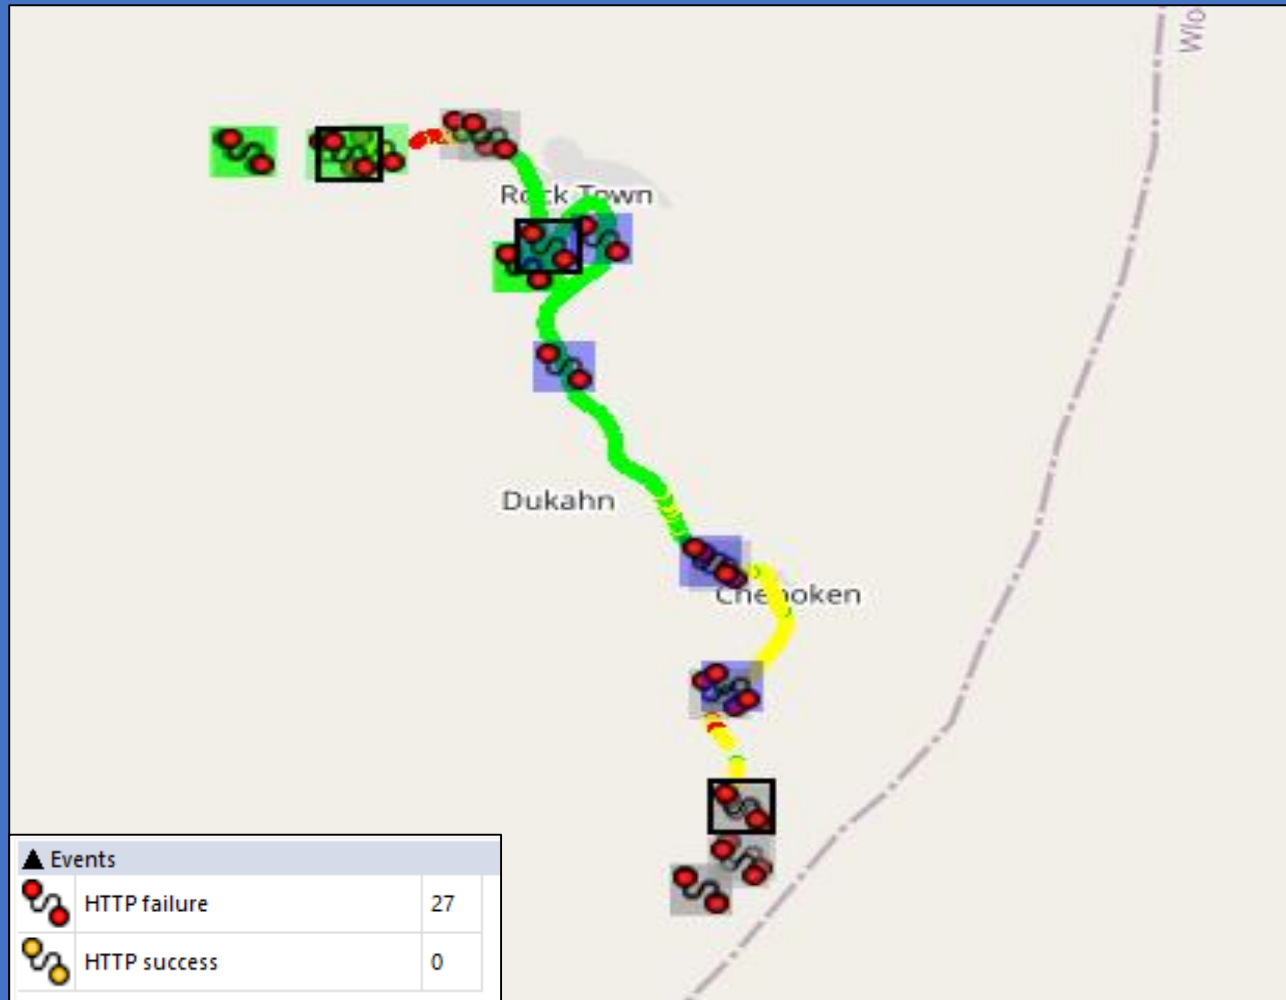
All 27 browsing attempts failed; Due to no internet connectivity

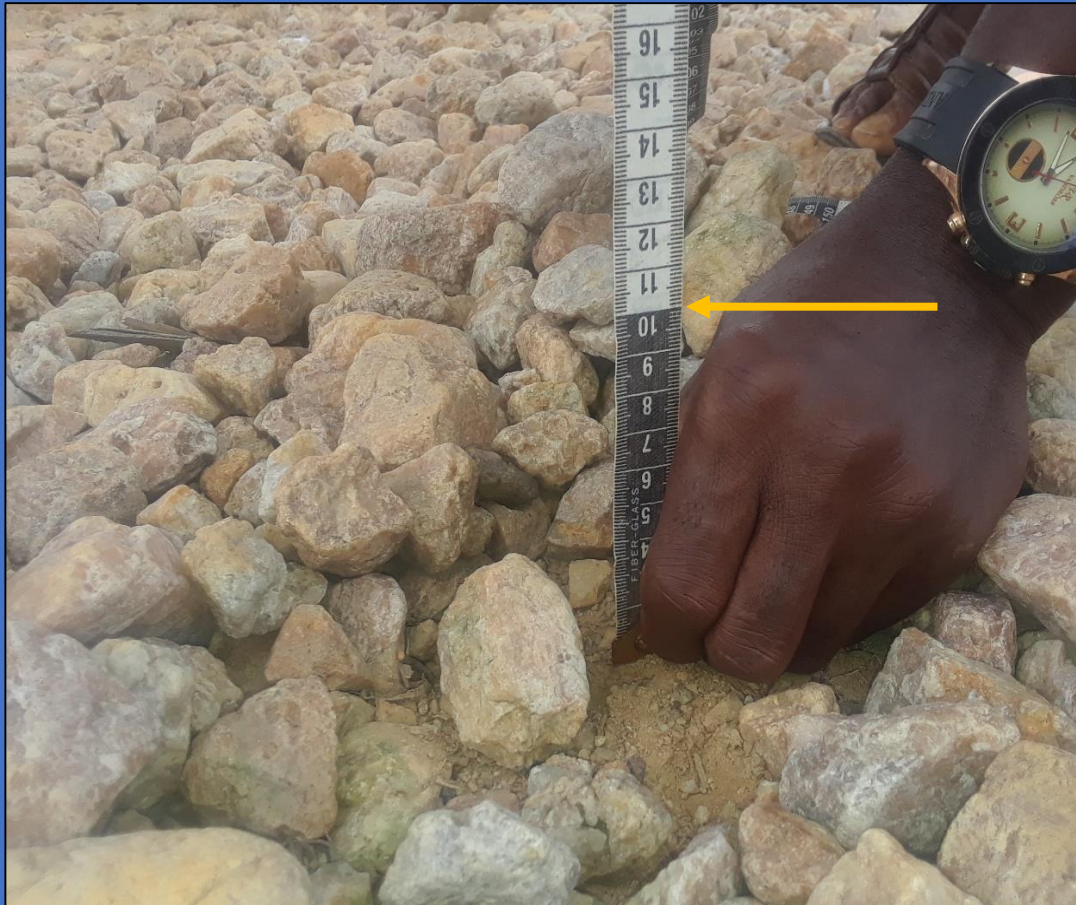
Gravel in the fence does not meet the 10cm standard.

- Increase crushed rocks in the site to atleast 10 cm height to avoid erosion.

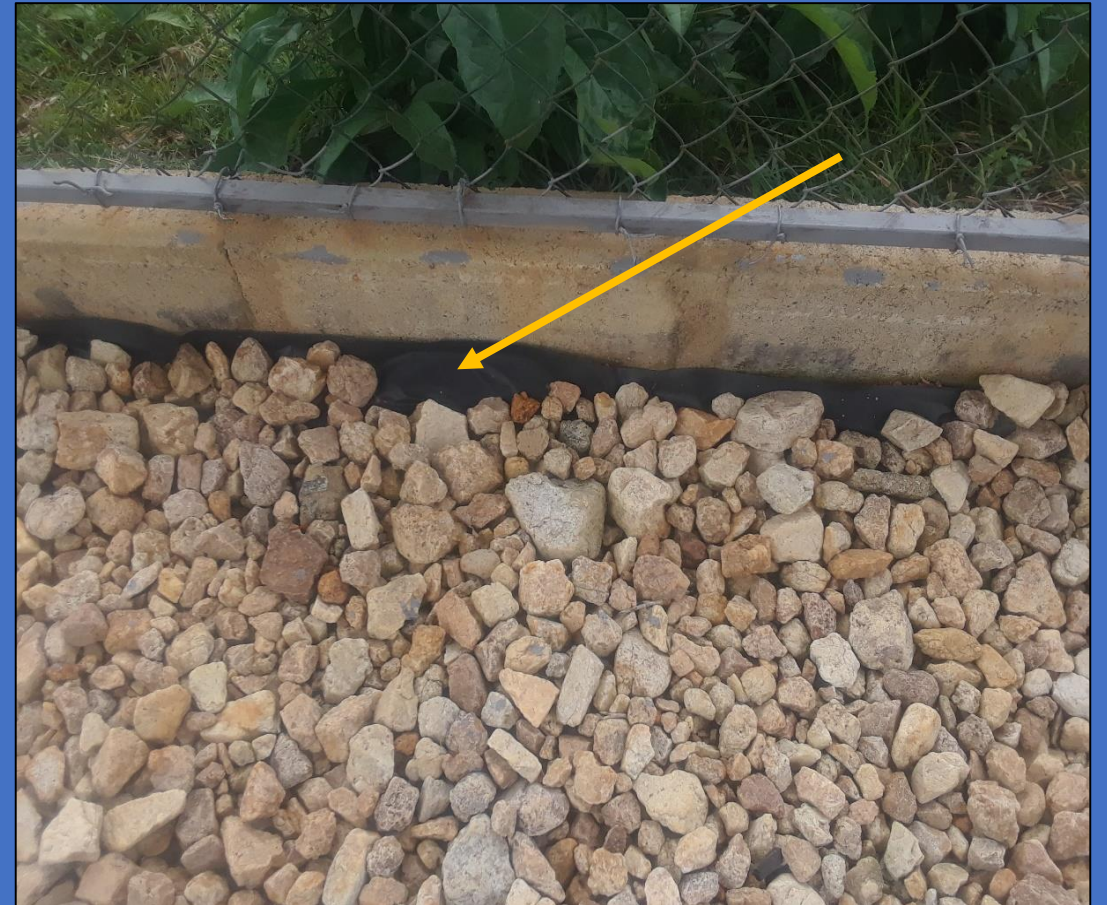
Plastic is visible in the site.

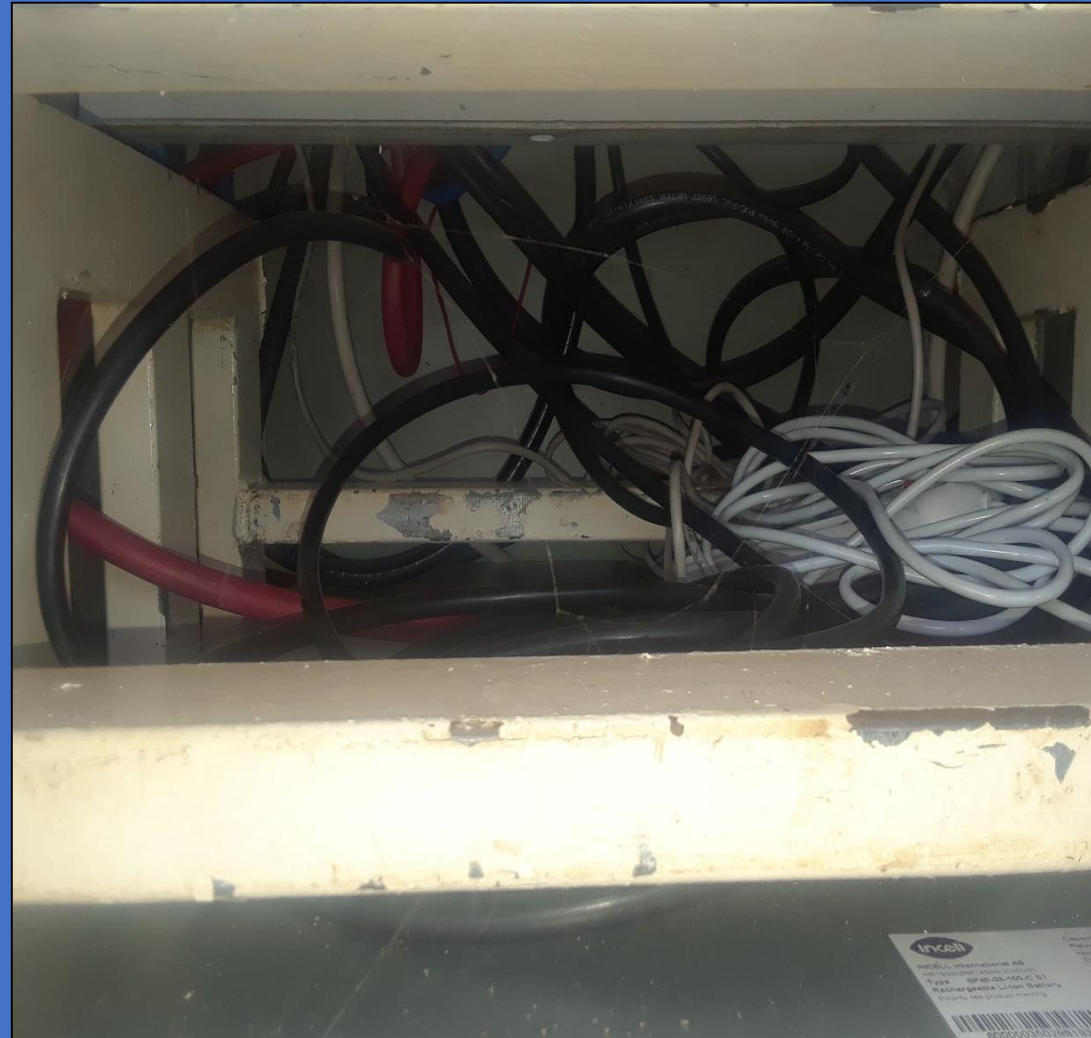
Cables in BTS Cabinet are not arranged properly.

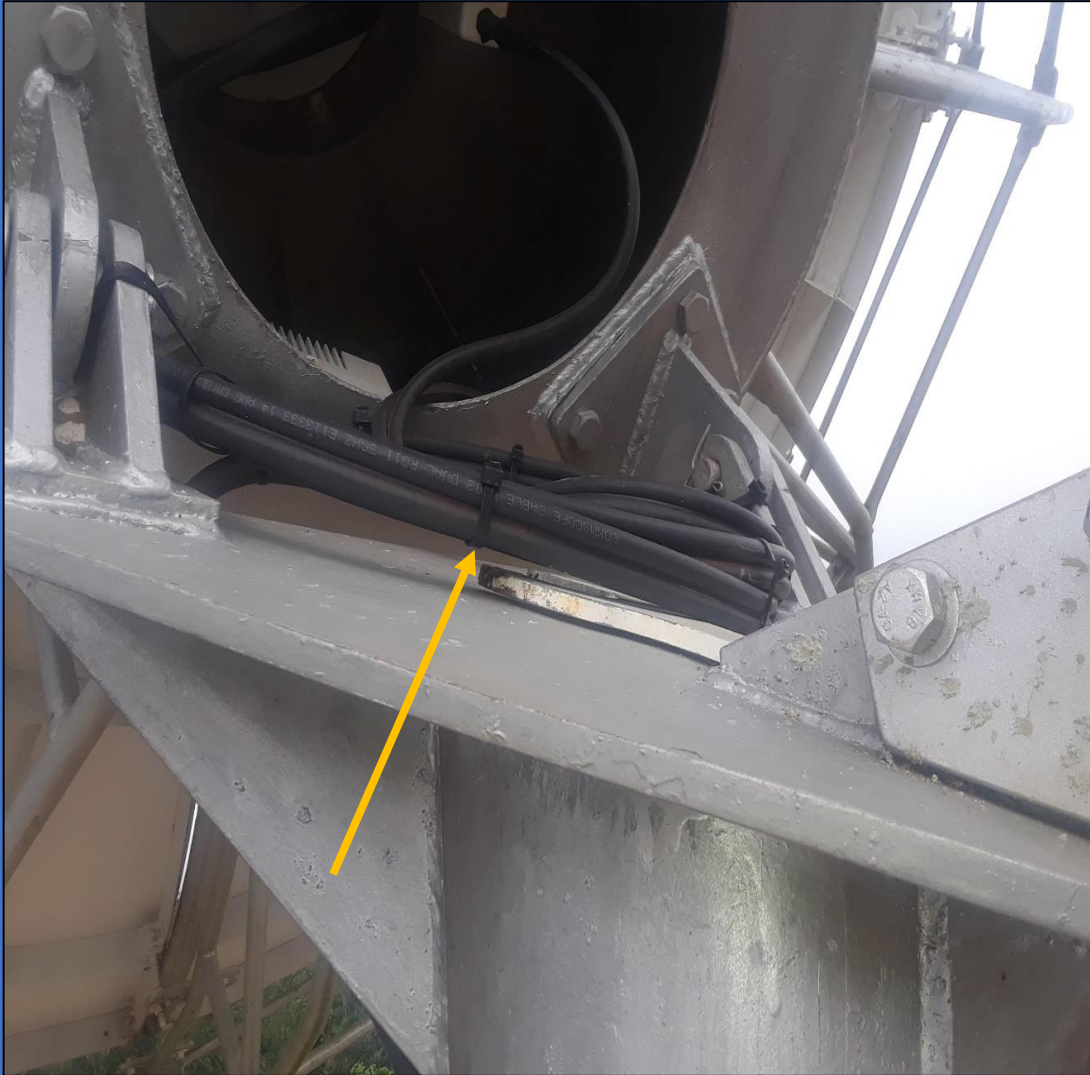
IF cable is more than one loop.

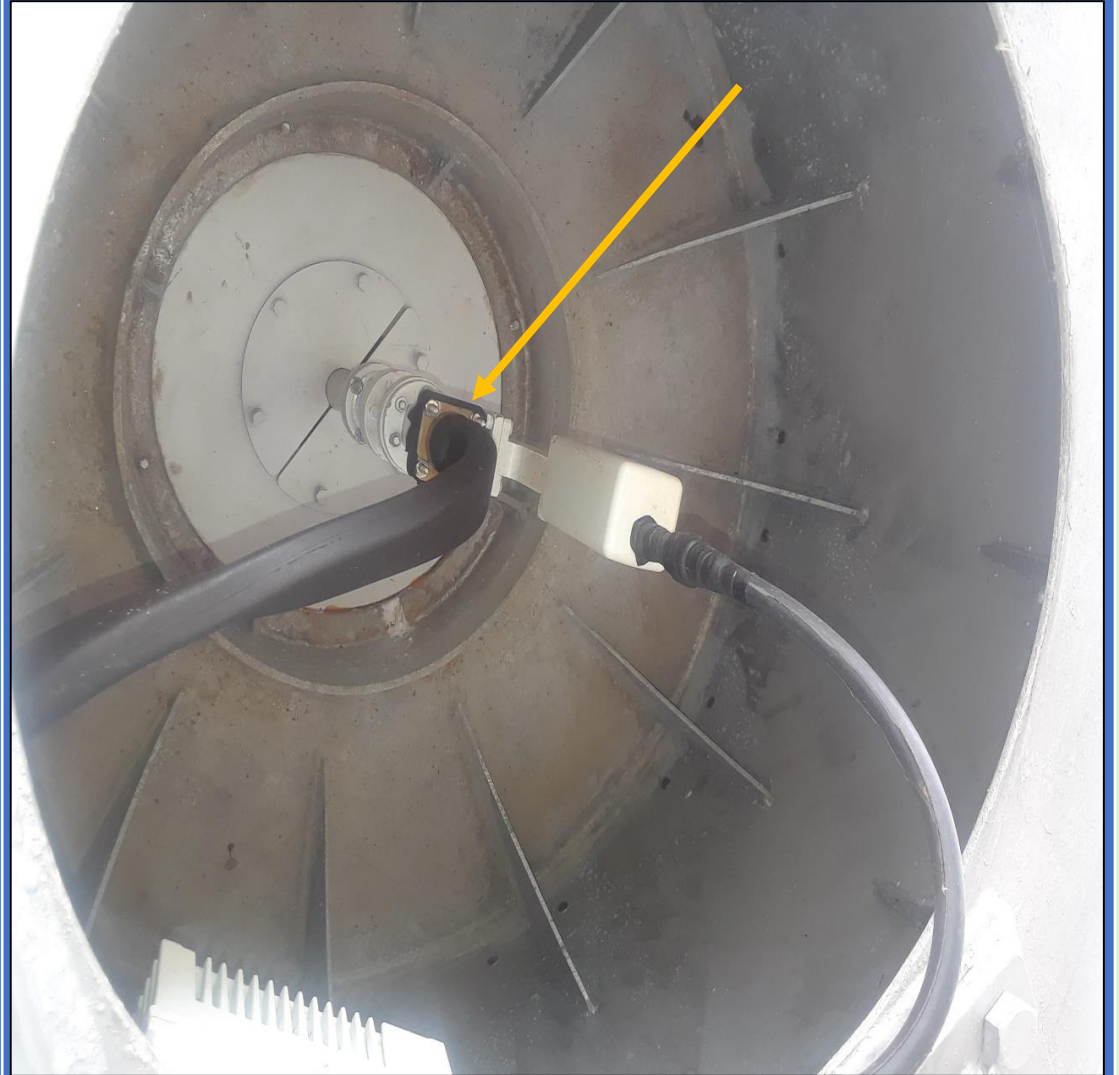
Waveguide is not protected with putty and tape.

- Grounding cable on the tower need to be changed to 70mm² coated grounding cable.
- Waveguide on the satellite dish and jumper cables on RRUs need proper puttying and taping.

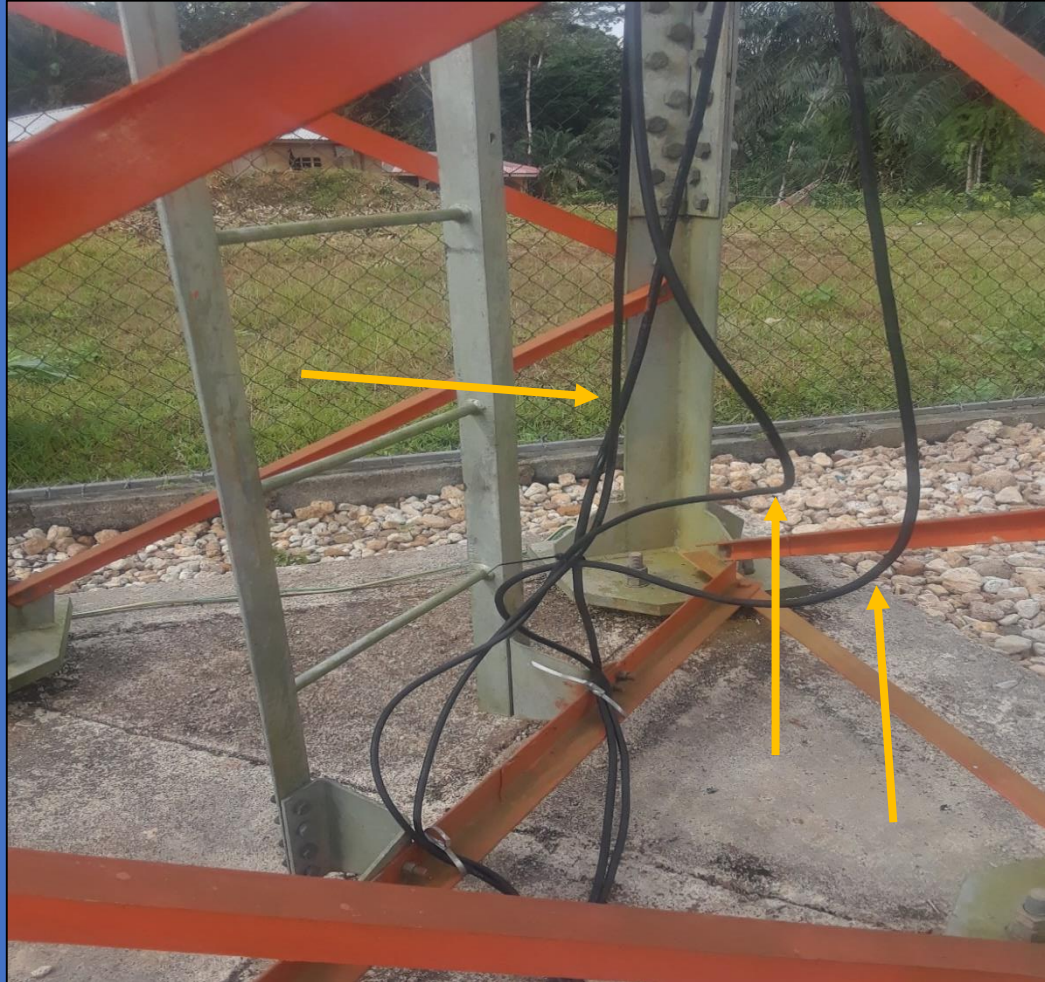
IF cable and other cables on the tower is loosely hanging.

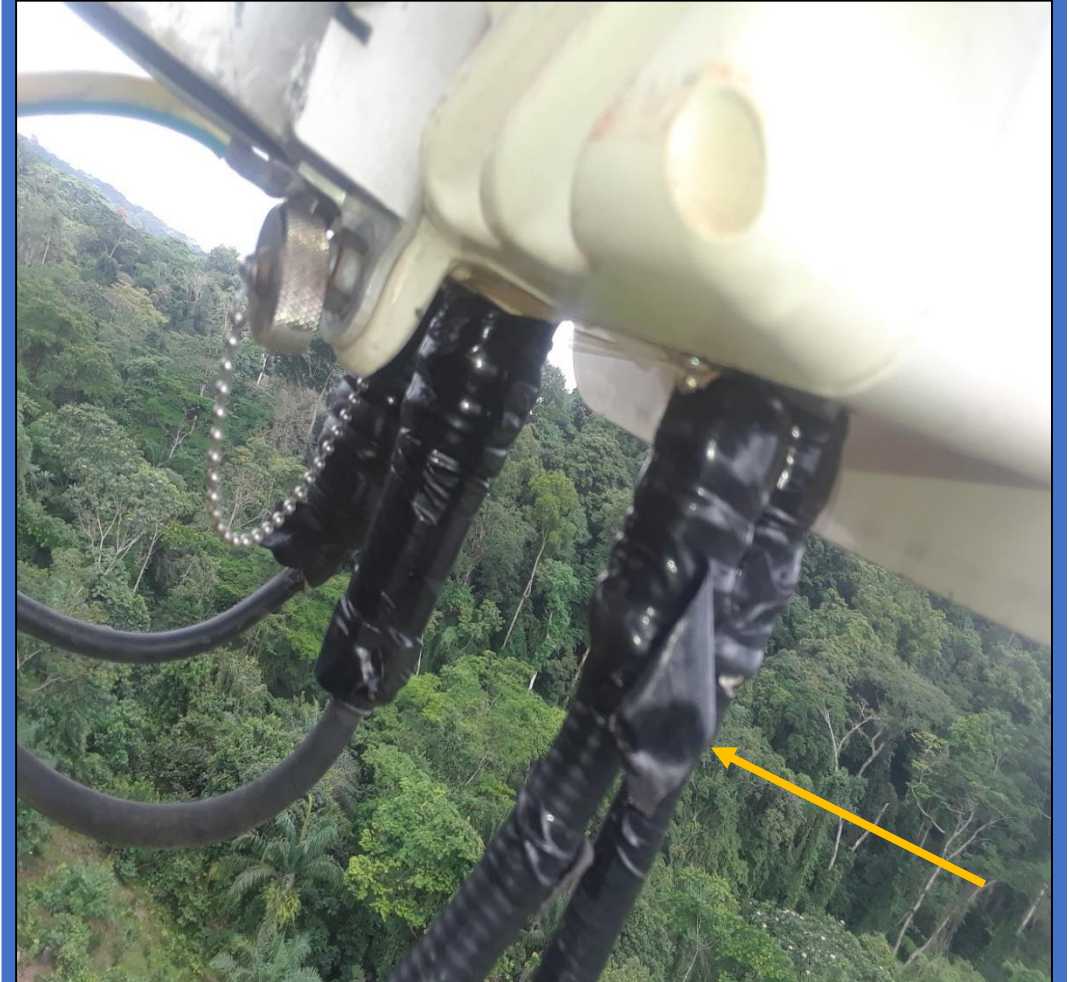
Tape around cables on tower for protection is loosened and not done well.

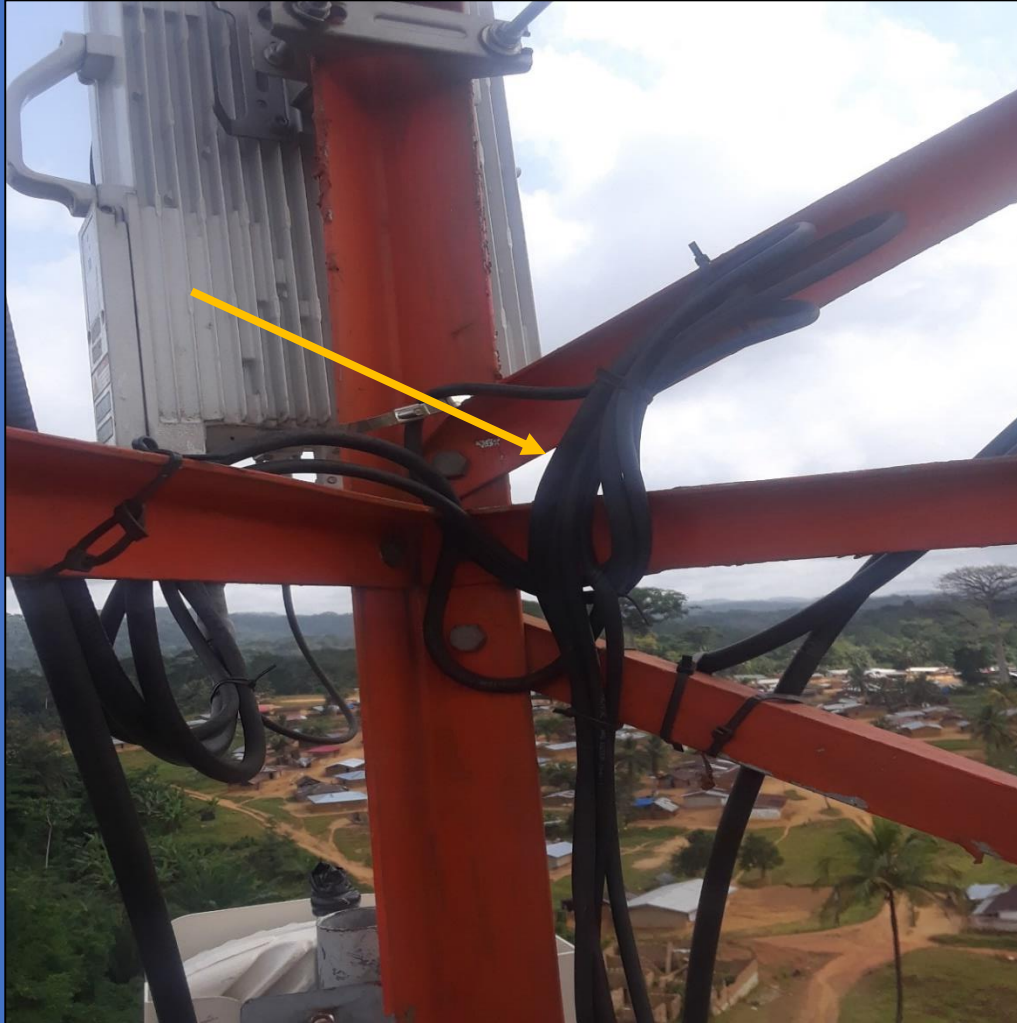
Cables on towers are not in cable holder and are not arranged.

- Cables running on resting place of tower need to properly placed into holders.
- Cables on the tower need cable holders.
- Grounding cables on the fence should be 25mm² or 35mm² coated.

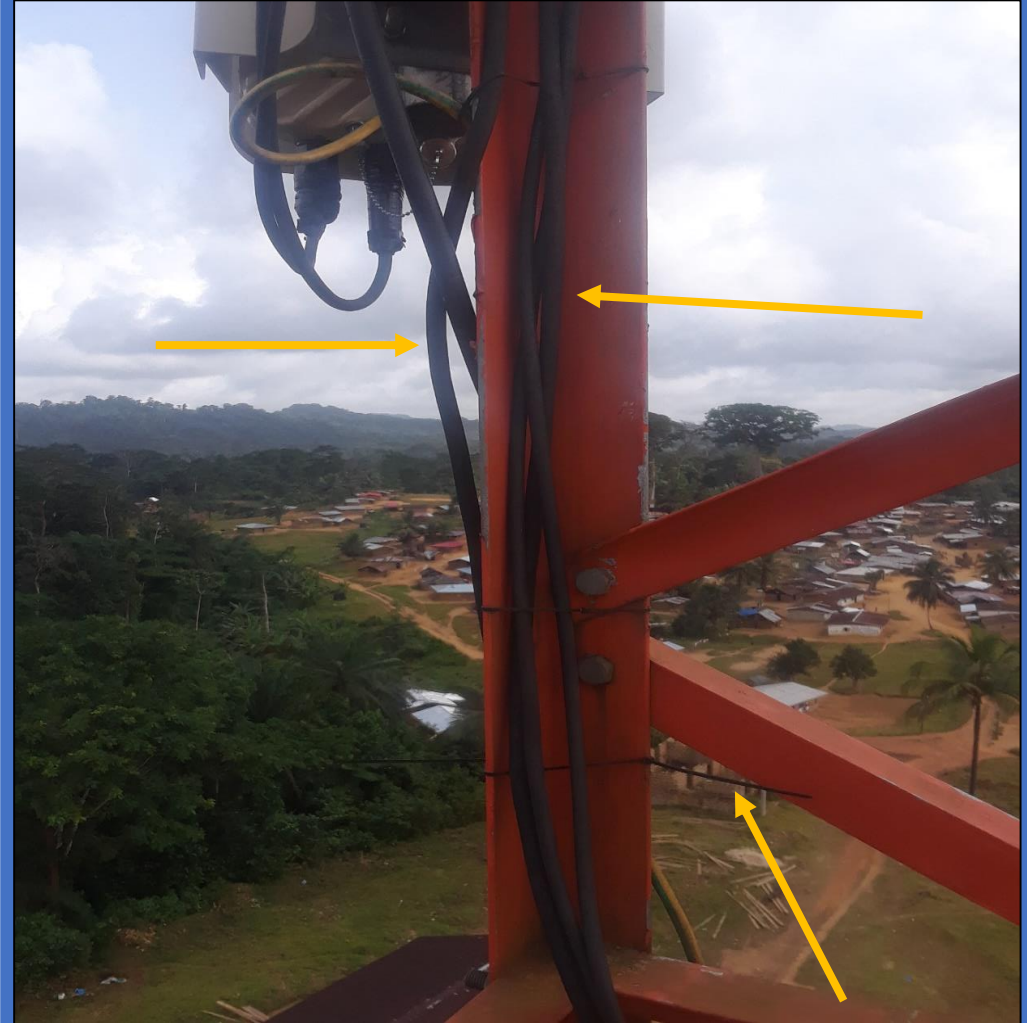
Cables are not properly laid, tie wraps are not cut, and cables are not in cable holder.

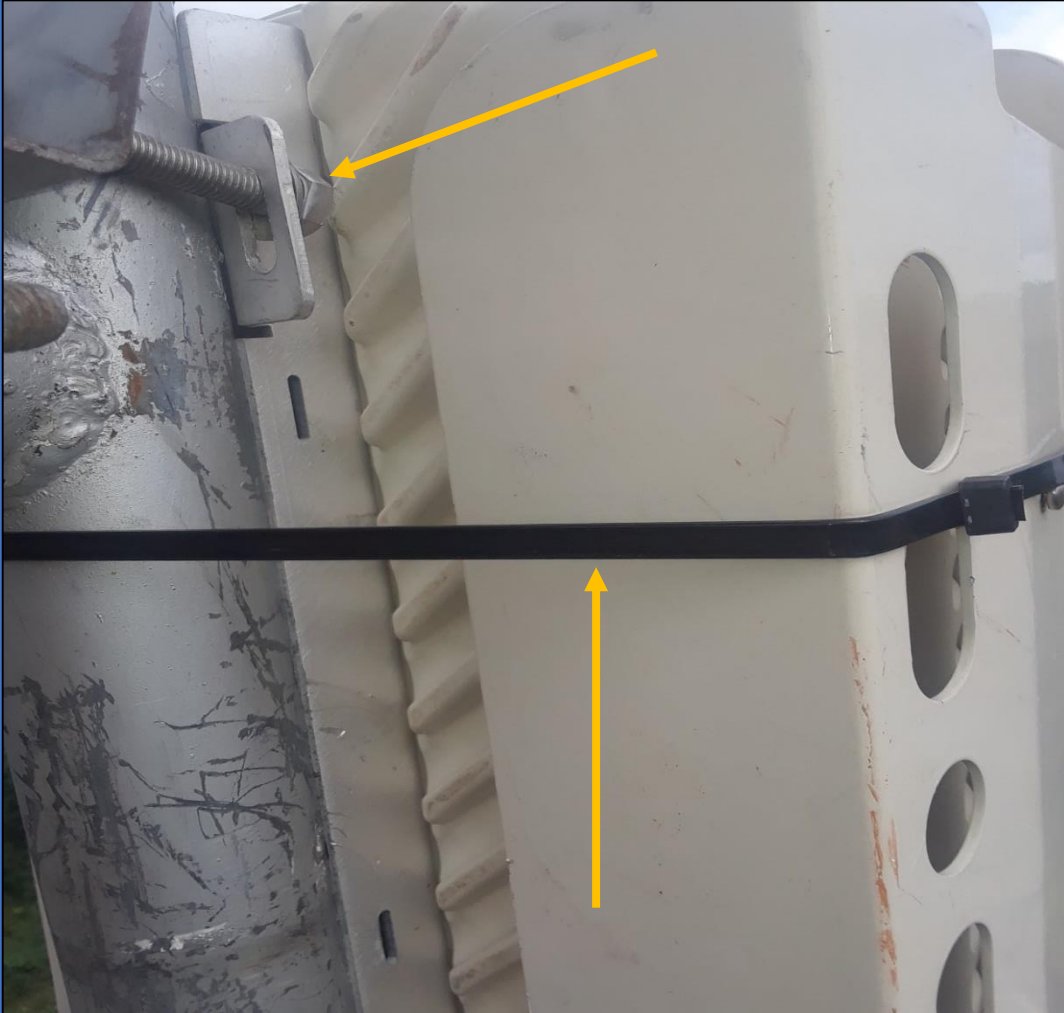
Equipment on tower is mounted with tie wrap; Bolts and nuts are not fully supporting the equipment.

- Grounding test needs to be conducted for grounding system at the site to avoid damage during lightning strike.
- Equipment with tie wrap on it needs proper bracket or else it will fall.

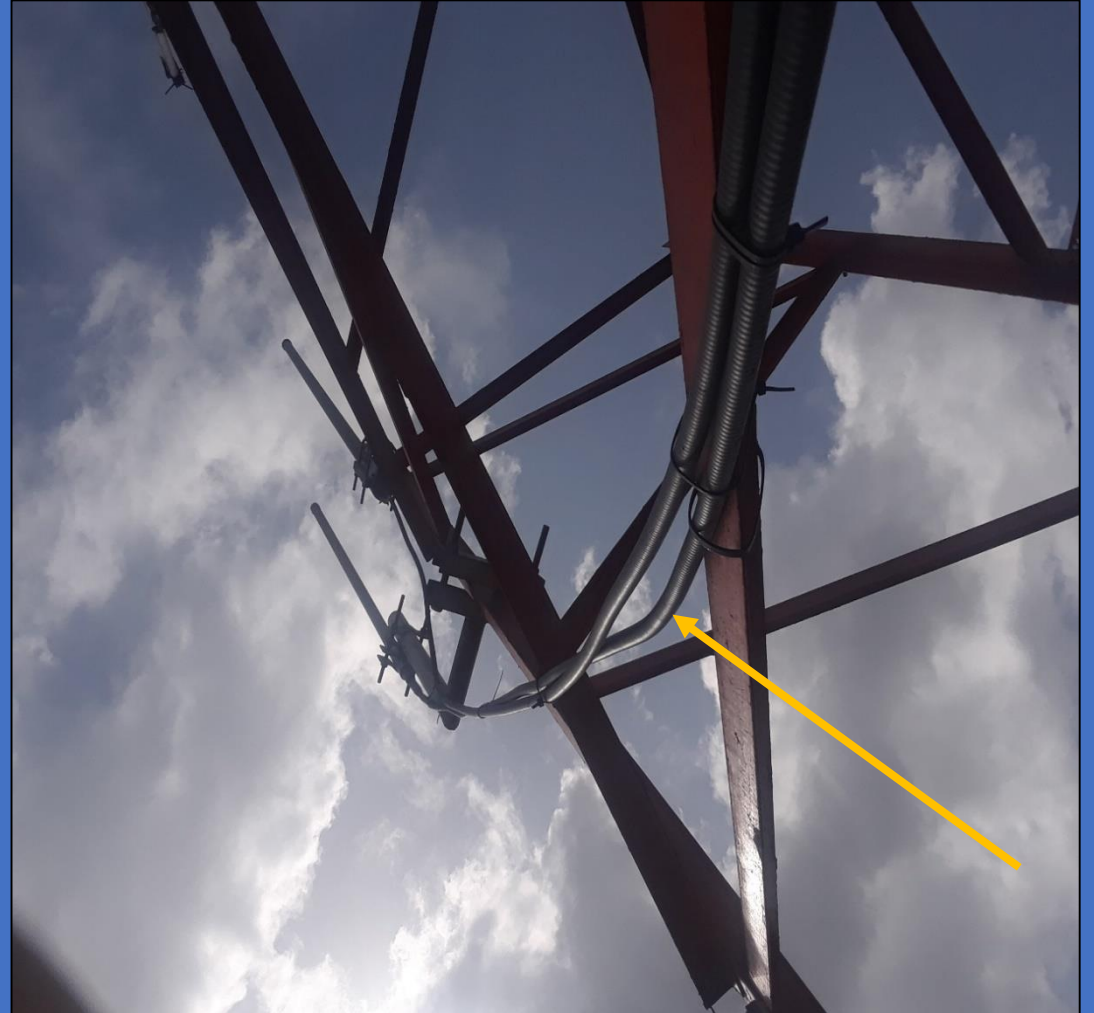
Jumpers on antennas are not in cable holder and is not properly laid.
