ABSOLUTE SOLUTIONS INC.

UNIVERSAL ACCESS FUND RTP
SITE VALIDATION & ACCEPTANCE
REPORT - PARLUKEN

15 February 2021

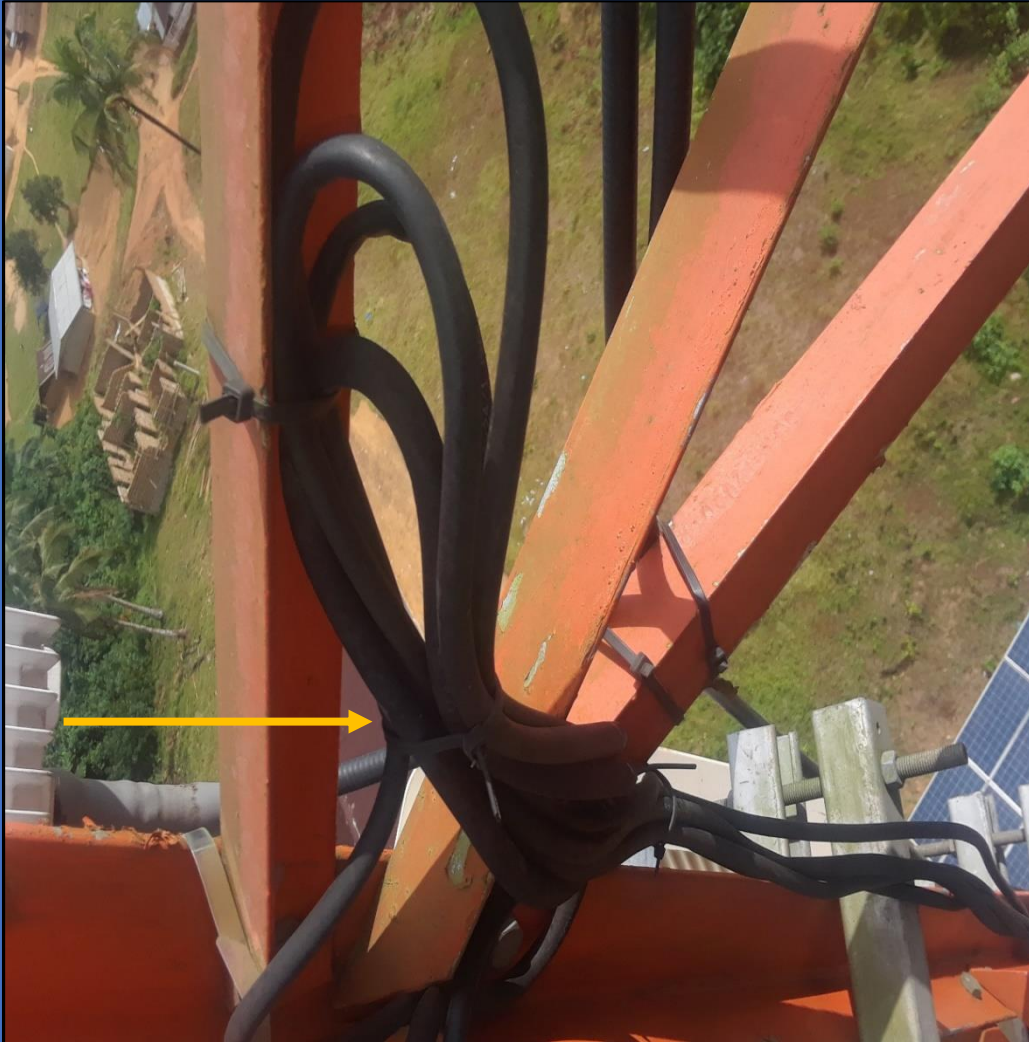
Jumper cables are bundled on tower; should be properly laid and looped.

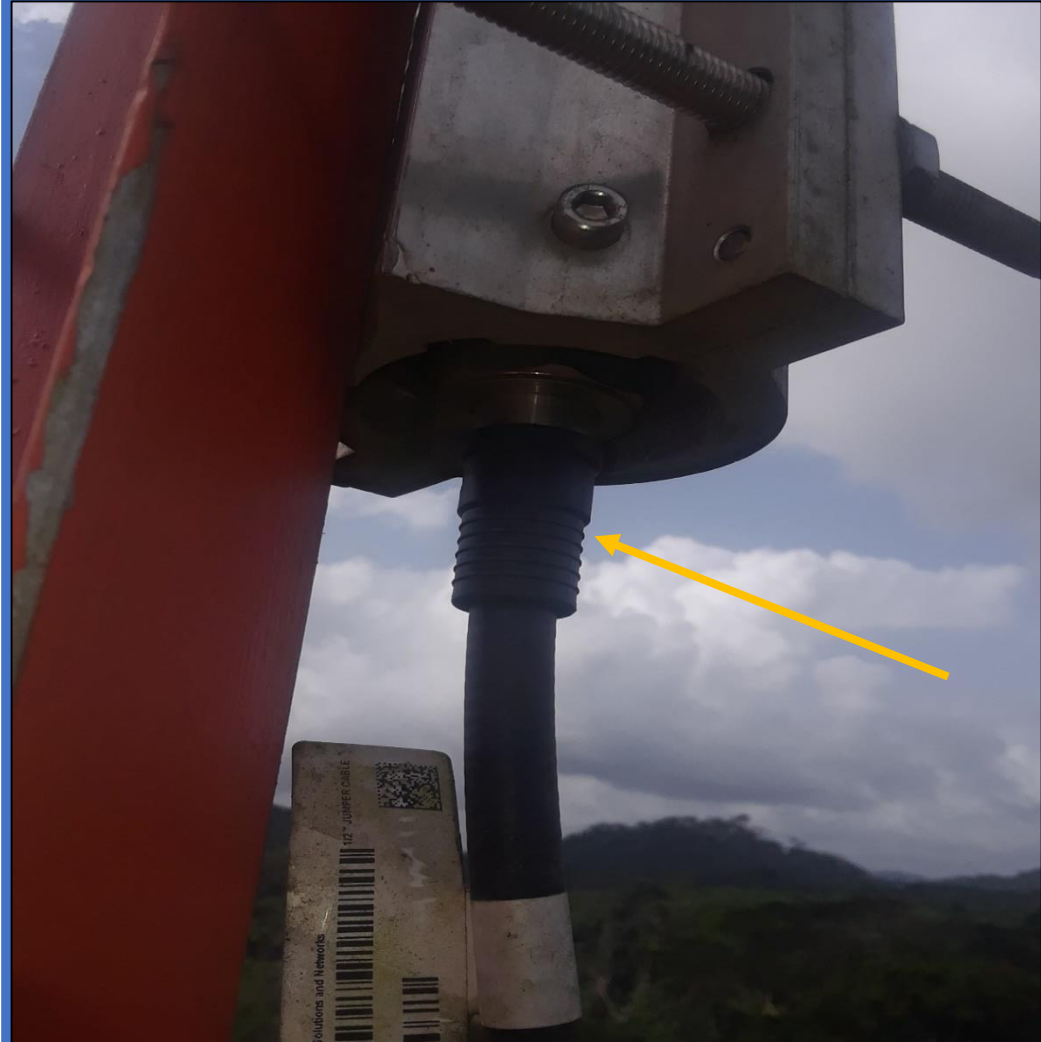
Jumpers on antennas are not protected with putty and tape.

- Grounding cable on the tower need to be changed to 70mm² coated grounding cable.
- Waveguide on the satellite dish and jumper cables on RRUs need proper puttying and taping.

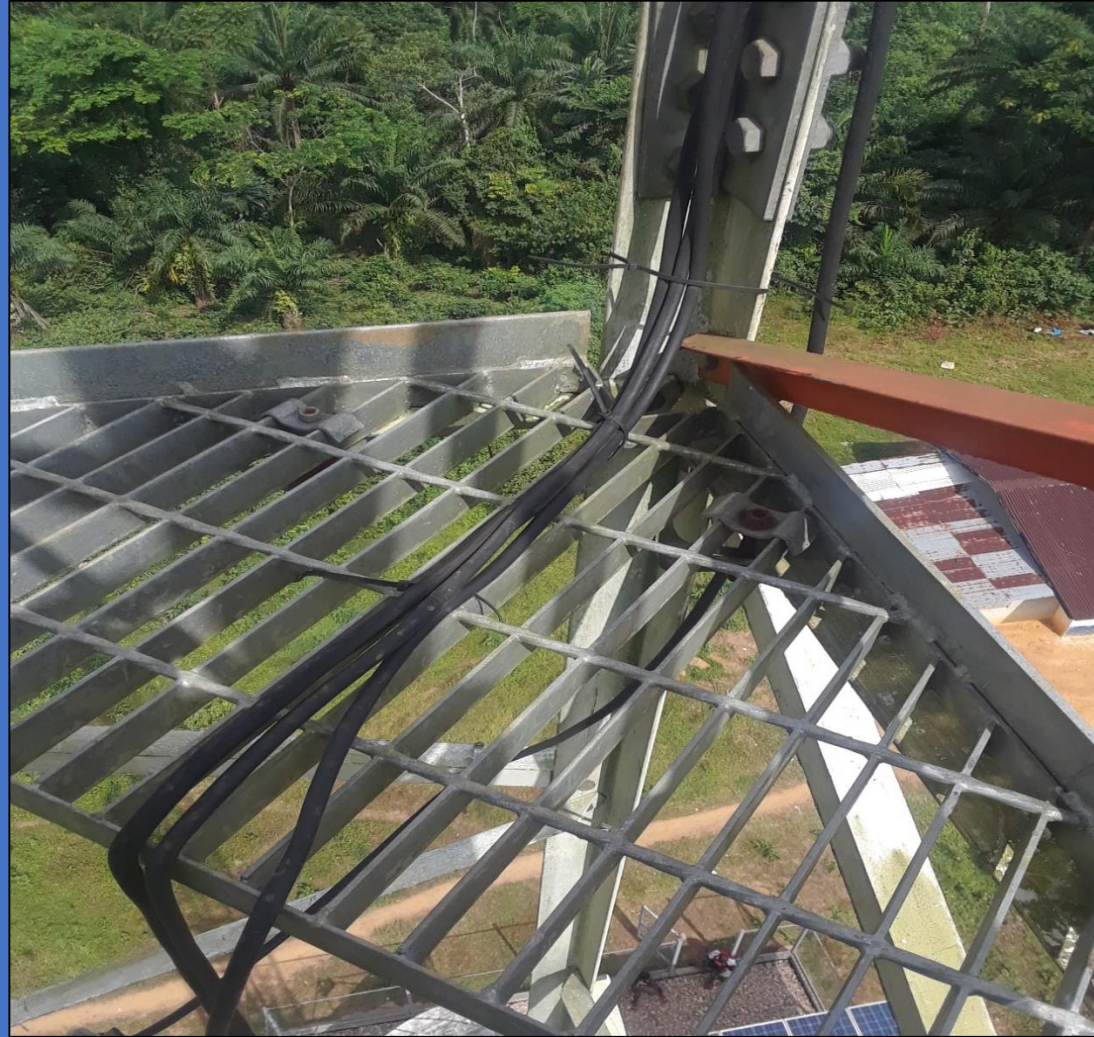
Cables are laid on the tower resting place; Improper installation.

- Cables running on resting place of tower need to properly placed into holders.
- Cables on the tower need cable holders.
- Grounding cables on the fence should be 25mm² or 35mm² coated.

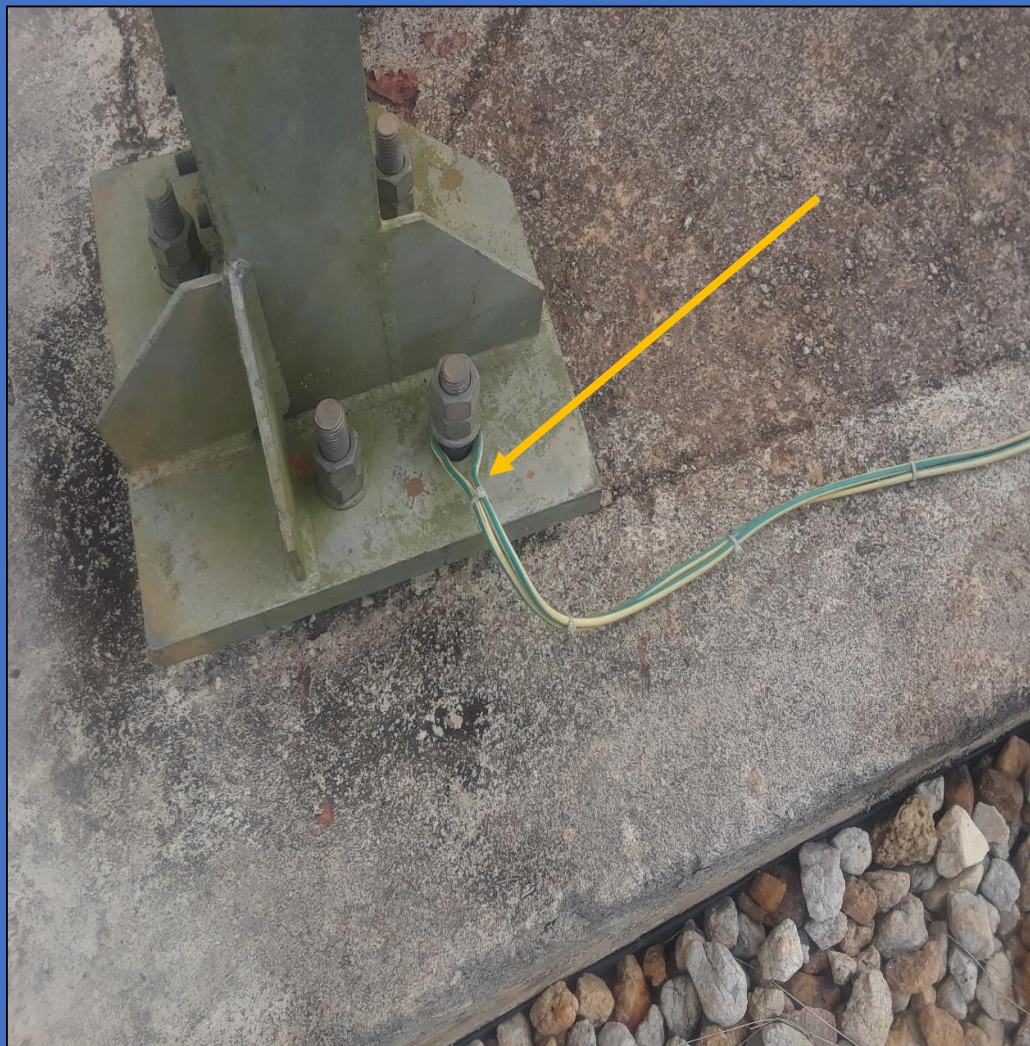
All four tower legs are not grounded, and the right cables are not used.

- Site need bi-annual maintenance.
- All metal tie wraps need to be changed to rubber tie wraps, to meet telecommunications installation standard.
- All four legs of the tower need to be grounded.

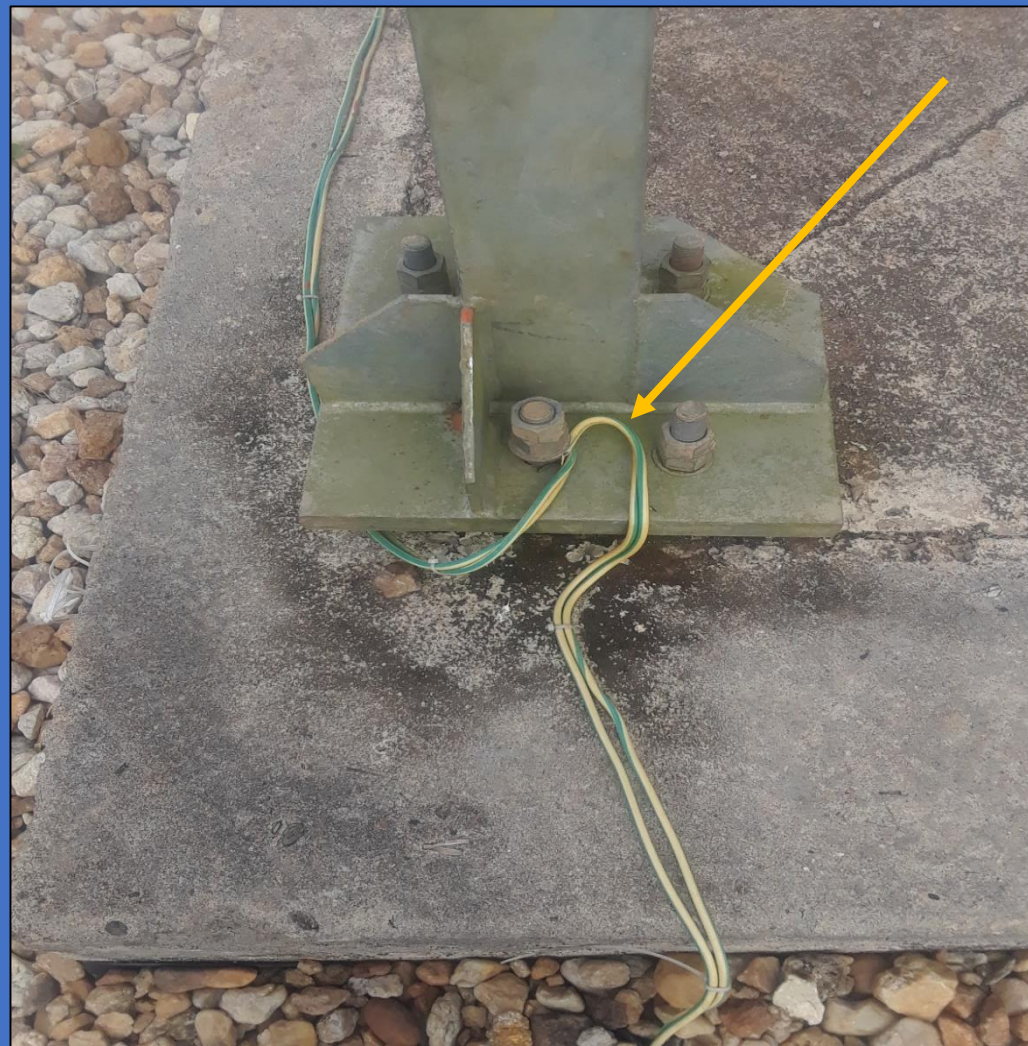
Tower legs are not grounded; Grounding cable used on tower legs is 25mm²

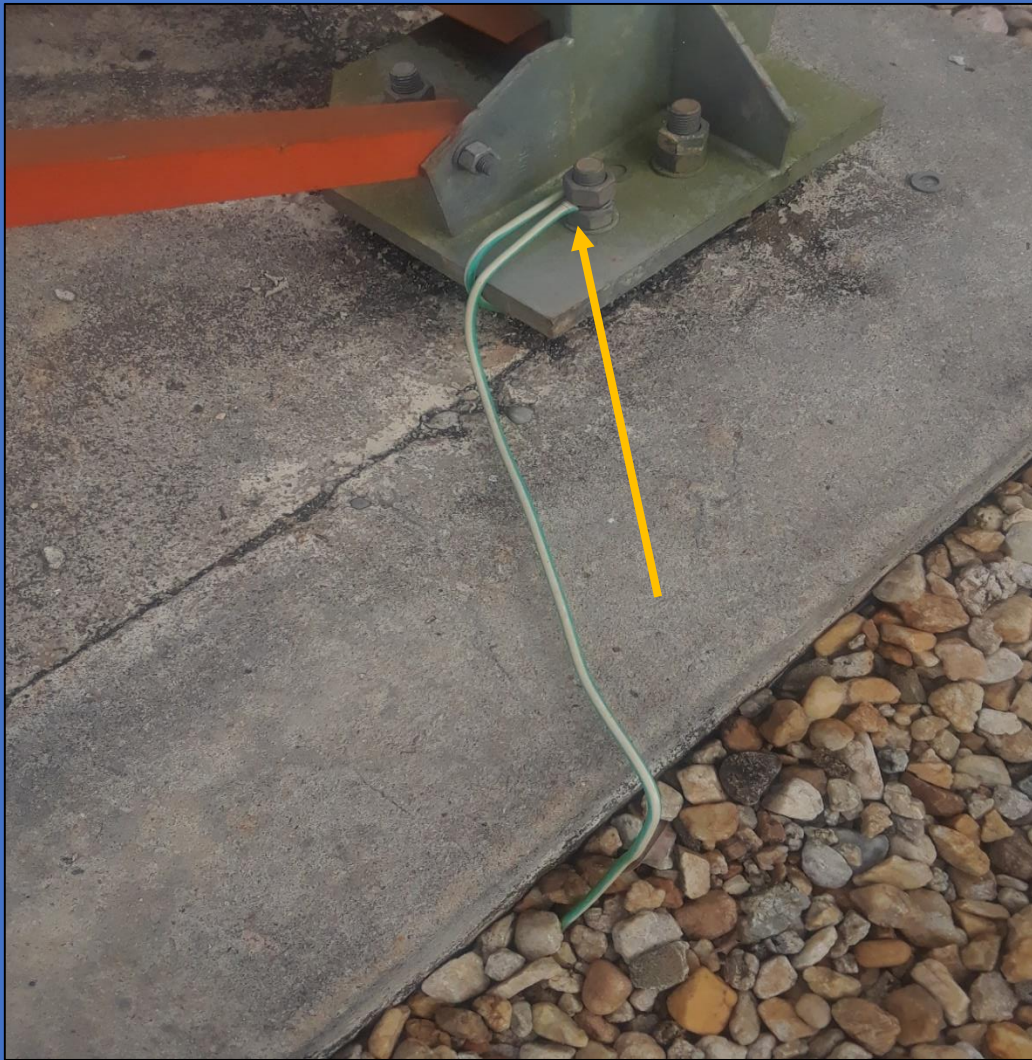
Tower leg wrongly grounded and no cable shoes.

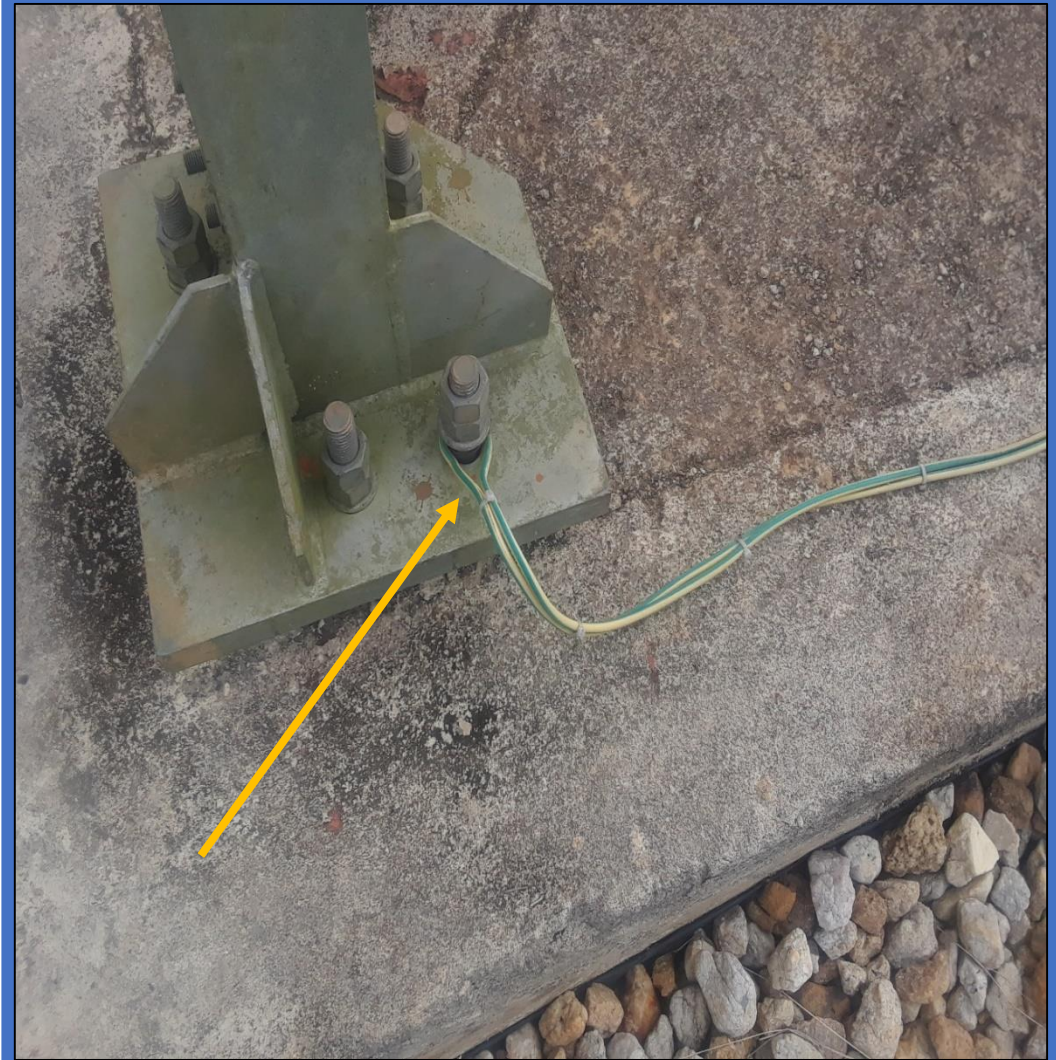
Tower leg not grounded.

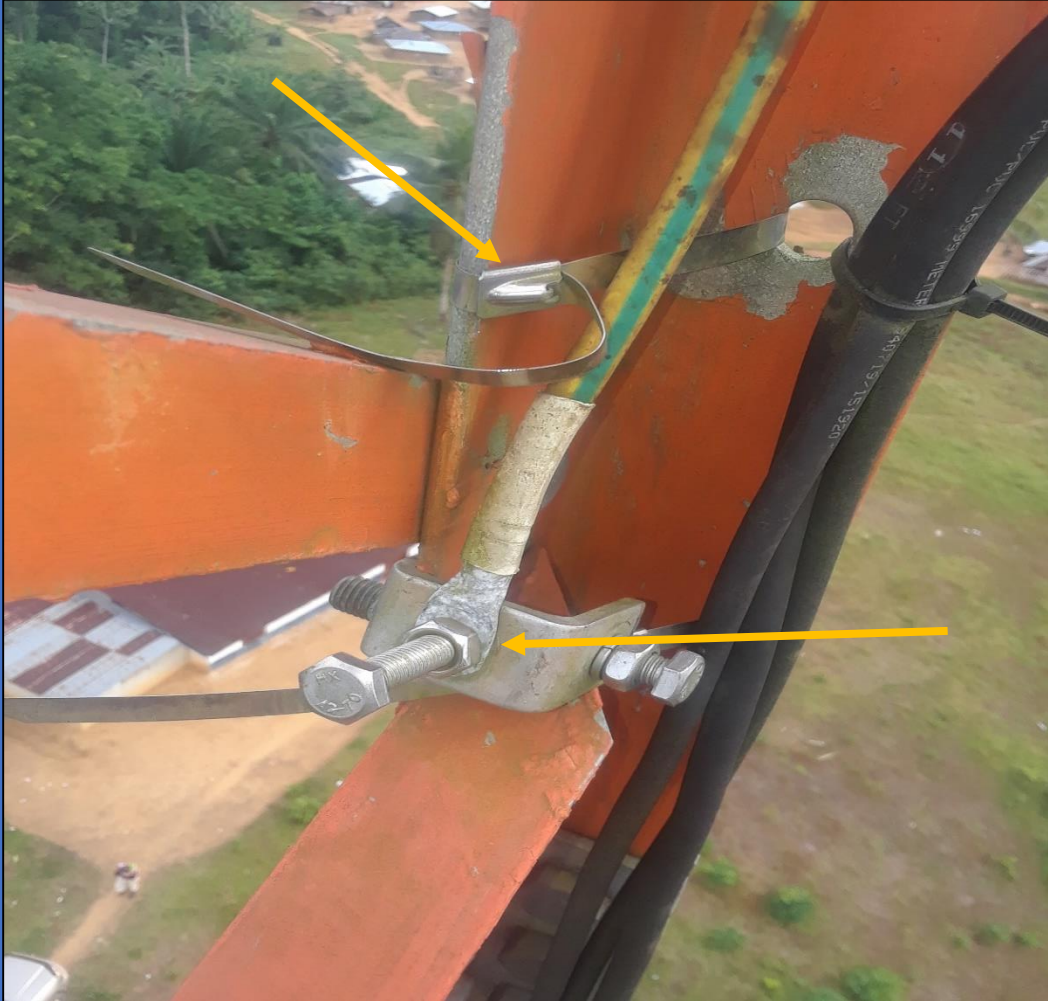
No busbar on tower; The grounding cable is 25mm²;
The tie wrap used is not the proper one.

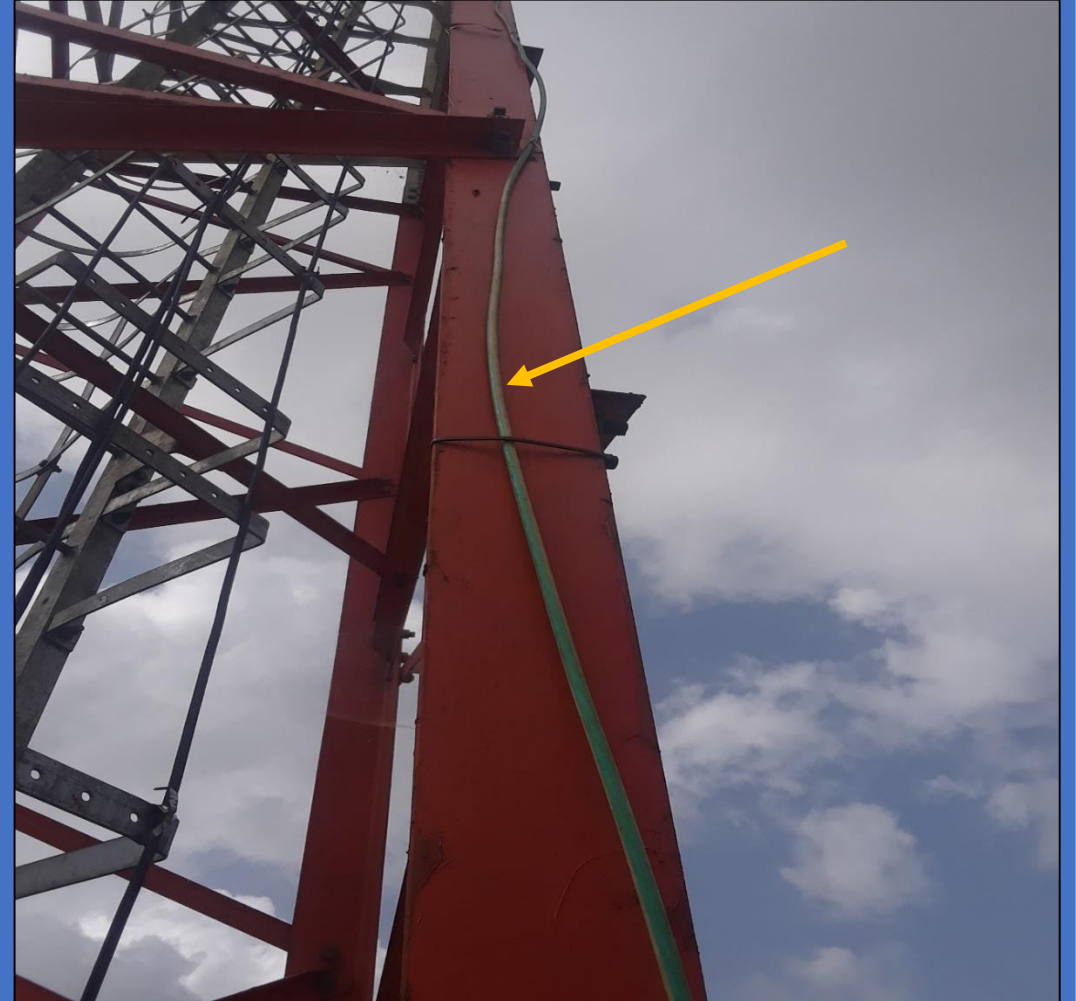
The grounding cable used is not the standard cable
for tower.
